Recording, Documentation, and Information Management for the Conservation of Heritage Places

ILLUSTRATED
EXAMPLES

Rand Eppich, *Editor*

The Getty Conservation Institute

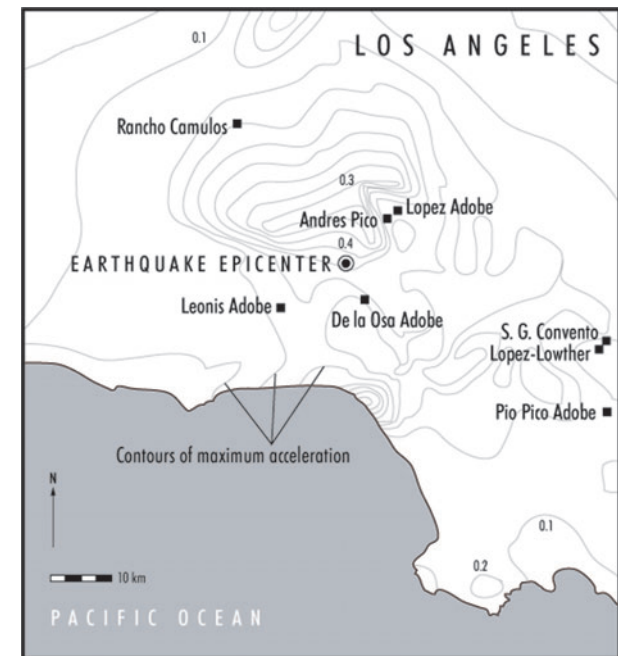
Map of Los Angeles, showing locations of historic adobe structures, the quake's epicenter, and contours of maximum acceleration. A map like this was used in planning site visits to the affected area. Drawing: Steven Rampton.

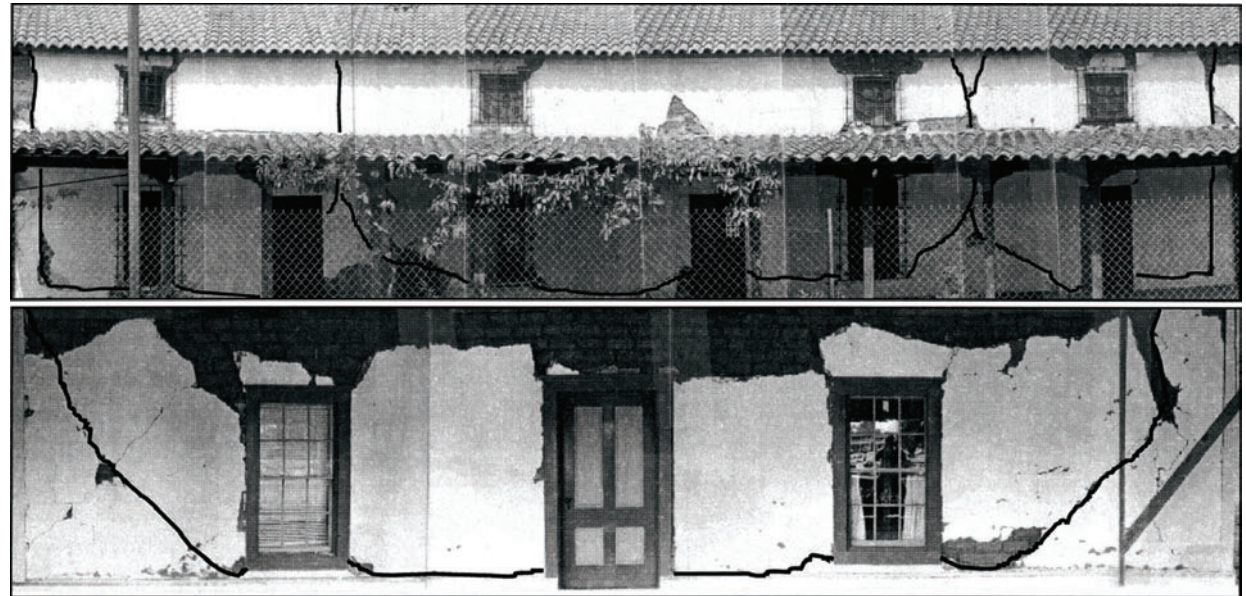
East exterior elevations of the Andres Pico Adobe, after initial structural assessment. Structural failures such as cracks caused by out-of-plane flexure were sketched on top of 35mm film and Polaroid images that were taken perpendicular to the building. This type of on-site assessment allowed engineers and architects to compile the final synthesis analysis and quickly move on to the next building. Photo: E. Leroy Tolles.

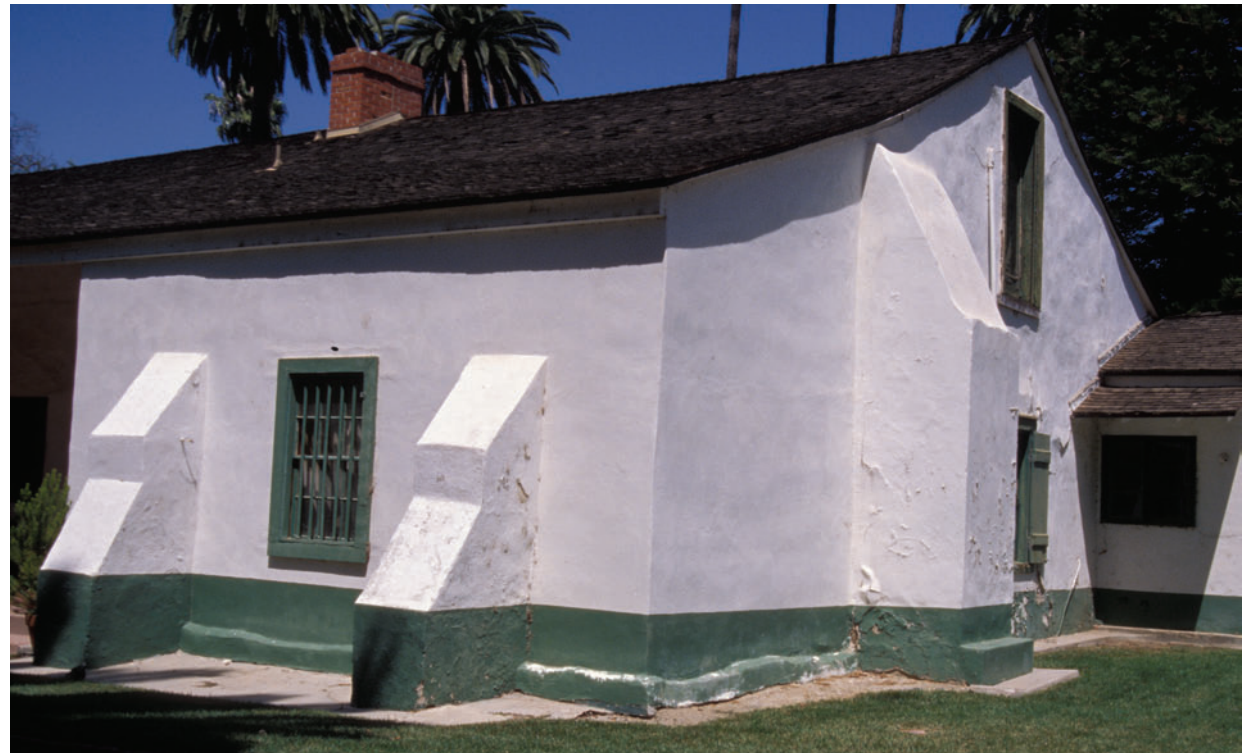
Southwest corner of the Rancho Camulos Adobe, after rehabilitation. Data collected during the rapid assessment were used to design earthquake mitigation techniques and devices that can be used on other historic earthen structures. Photo: Gail Ostergren.

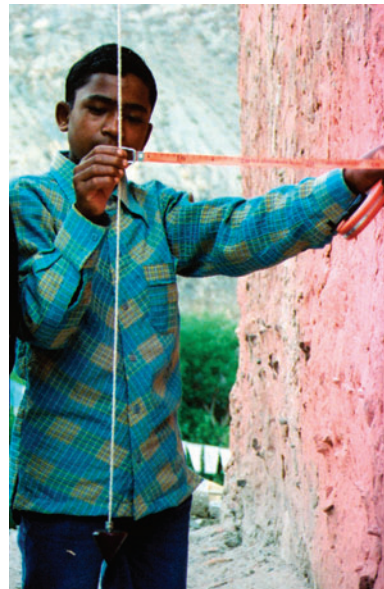
A worker measuring exterior deformation in reference to a vertical plumb line at Chango Temple. Photo: © Sandeep Sikka.

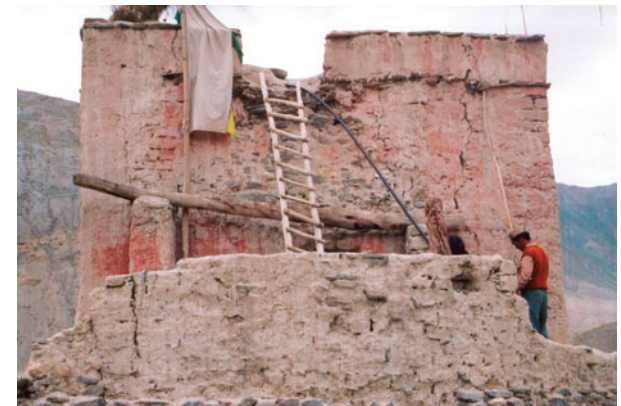
A local worker recording the front elevation of Chango Temple. Manual recording techniques, although labor intensive, are readily available and allow conservators to study buildings in great detail. Photo: © Sandeep Sikka.

Some problems arose using this process. When the interior and exterior drawings did not align, the measurements had to be completely repeated for the entire building. The indigo-dye reference lines were not permanent and faded after a short time. Also, the 50-centimeter measuring grid could have been adapted to allow for the recording of smaller deformations. The reverse was also true: if a wall was relatively straight, fewer measurements could have been taken, speeding up the process. A heavier plumb bob, greater than 200 grams, should also have been used, as high winds disturbed the exterior vertical reference line. Another tool that could have improved accuracy was a bubble line level to ensure that the reference lines were exactly horizontal.

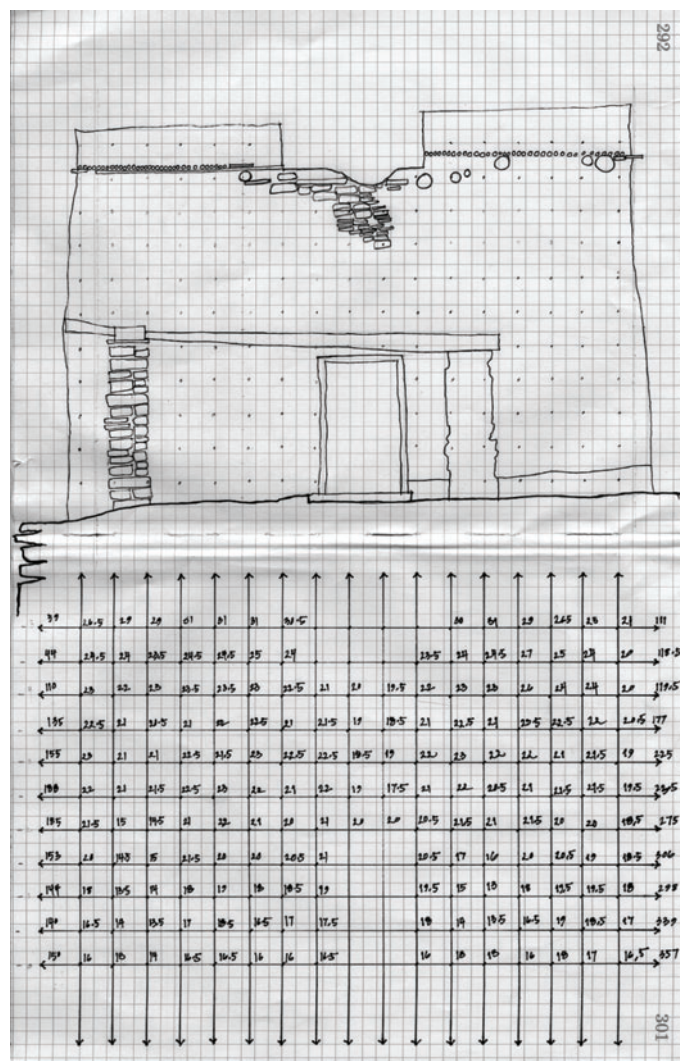
Hand-drawn front elevation of Chango Temple, showing all out-of-plumb measurements at every 50 centimeters. Recording the wall deformation assisted conservators in understanding the causes of deterioration. Drawing: © Sandeep Sikka.

During the next phase, evaluation, the drawings and wall profiles generated from these measurements showed outward movement of the upper courses of the walls due to excessive roof loads. Increased precipitation in the region over the last few years prompted local craftspeople to waterproof the roofs by adding layers of compacted mud. These additional layers have drastically increased the roof load, resulting in either sagging of structural members or outward movement of the walls near the ceiling. The drawings also showed outward bulging in several places at the bottom of the walls in the interior. This was caused by excessive moisture swelling the ground outside the buildings, creating a lateral thrust on the lower masonry courses.

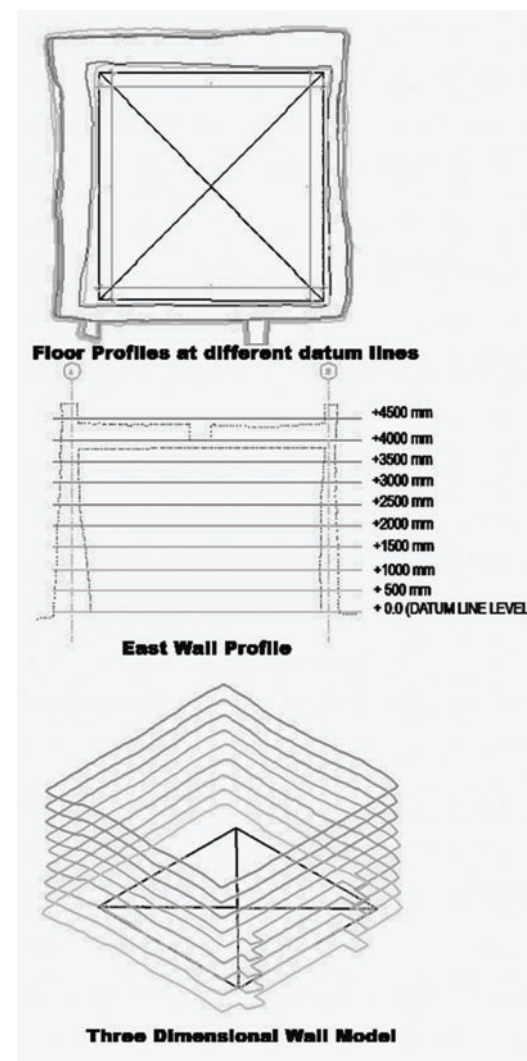
The manually recorded measurements were entered into AutoCAD, a computer drafting program, for further analysis. Drawing: © Sandeep Sikka.

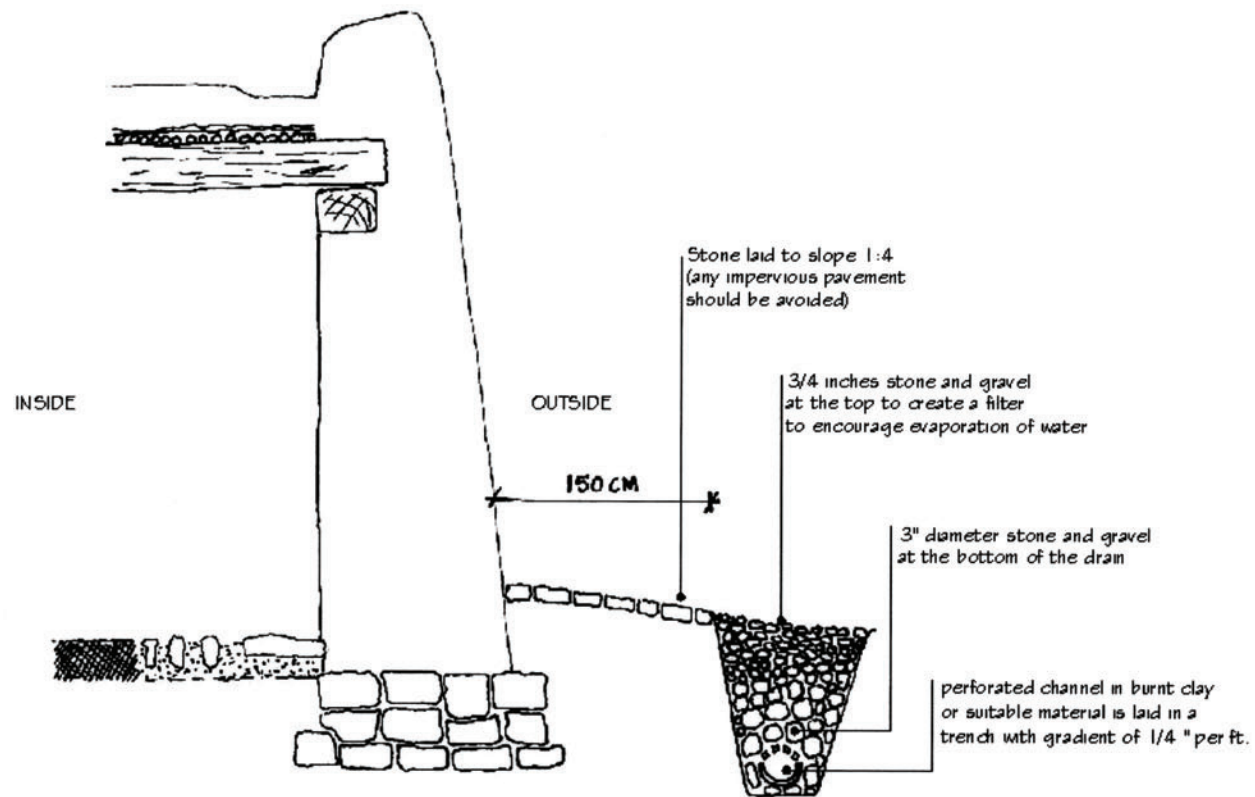
Bulging walls and structural cracks developed due to the horizontal thrust from the surrounding groundwater. Issues of drainage were resolved by sloping earth away from the walls and burying perforated drains. Drawing: © Sandeep Sikka.

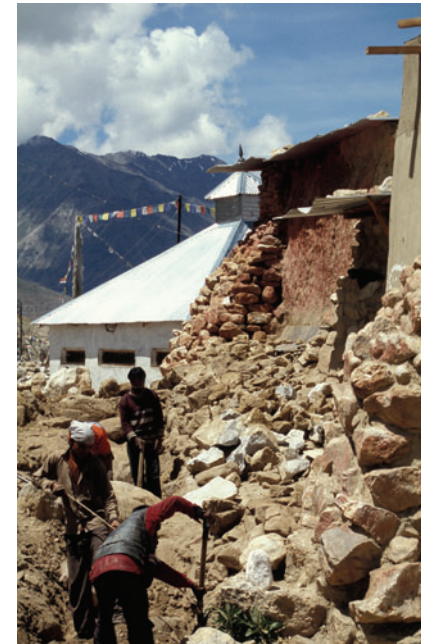
Workers burying perforated drains. Photo: © Sandeep Sikka.

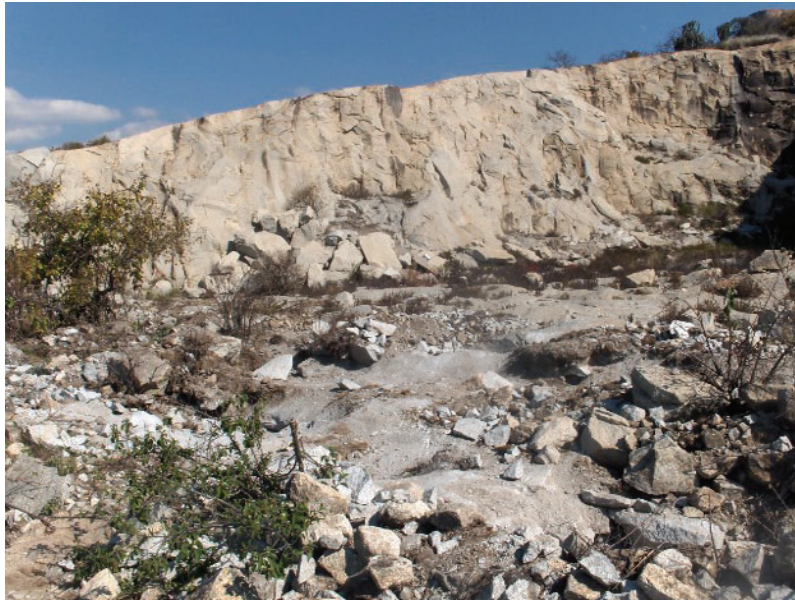
Illegal surface strip mining for gold and other minerals using heavy equipment and blasting has disrupted the natural landscape. Photo: © Geofree Chikwanda.

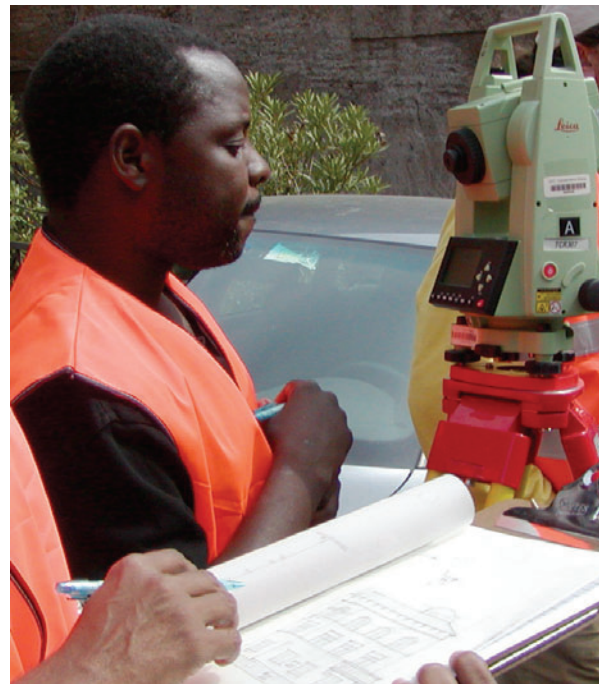
The author using a total station theodolite. The total station and its onboard computer calculate the position of a point through trigonometry by recording the horizontal and vertical angles and distance. Photo: Rand Eppich.

The main tools utilized for the field delimitation were a total station theodolite and a handheld global positioning system (GPS) receiver. A total station theodolite is a standard survey device that locates points by measuring distances as well as horizontal and vertical angles. It differs from a theodolite in that it measures not only angles but also distances and includes an onboard computer.

The total station theodolite used in this survey was a Topcon GTS200 series. Placed atop a tripod, it consists of a powerful telescope mounted on a base that rotates both horizontally and vertically. Features such as roads, buildings, and property boundaries are identified by looking through the telescope at a prism or reflector target on a pole held by another surveyor. These features can be as close as 2 meters or up to 5 kilometers away, depending on the telescope. When the surveyor focuses the telescope on the prism, the total station theodolite accurately records the horizontal and vertical angles and distance. Distance is measured with a feature known as electronic distance measurement (EDM). An infrared beam is projected from the total station theodolite, which “bounces” back to its source and, using a timing device, the distance is calculated. Many total station theodolites also have a mode known as reflectorless, meaning that within short distances of 100 meters or less, a prism or reflector is not needed. This allows the instrument to be operated by only one surveyor, which is useful when measuring points difficult to access, such as cliff faces or ridge beams. Trigonometric calculations are then performed by the onboard computer, combining the horizontal and vertical angles with the distance measurement to determine an XYZ coordinate, usually within a centimeter. By recording and then

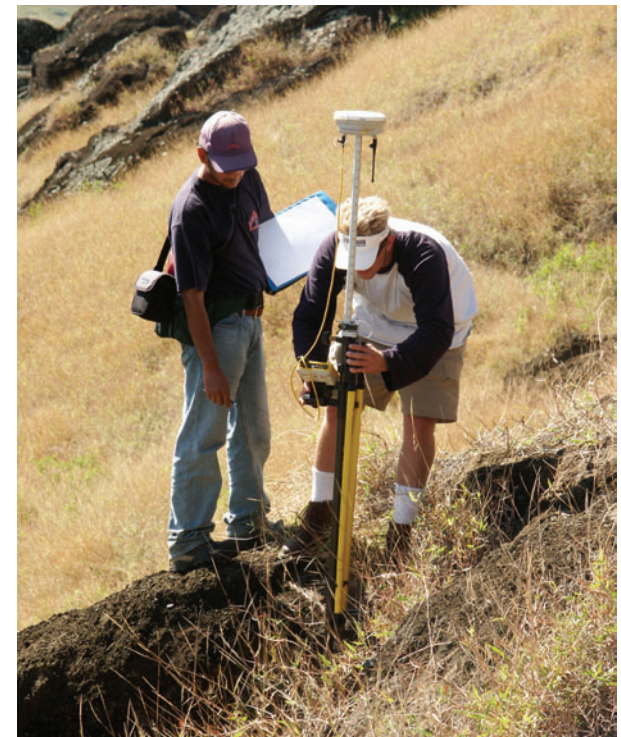
Cristián Arévalo Pakarati (*left*) and surveyor Matt Bates collecting data using a GPS rover unit. Photo: Jo Anne Van Tilburg © Jo Anne Van Tilburg/Easter Island Statue Project.

The receiver used was a single-frequency system that required no cables and operated on standard batteries. This system is expandable, adaptable, light, and mobile and can achieve centimeter-level accuracy. In the Stop/Go surveying procedure that was used, one of two receivers was stationary and the other—the rover—was mounted on a survey pole. When the rover was held in front of the stationary receiver, contact was established via an infrared port and the units were synchronized.

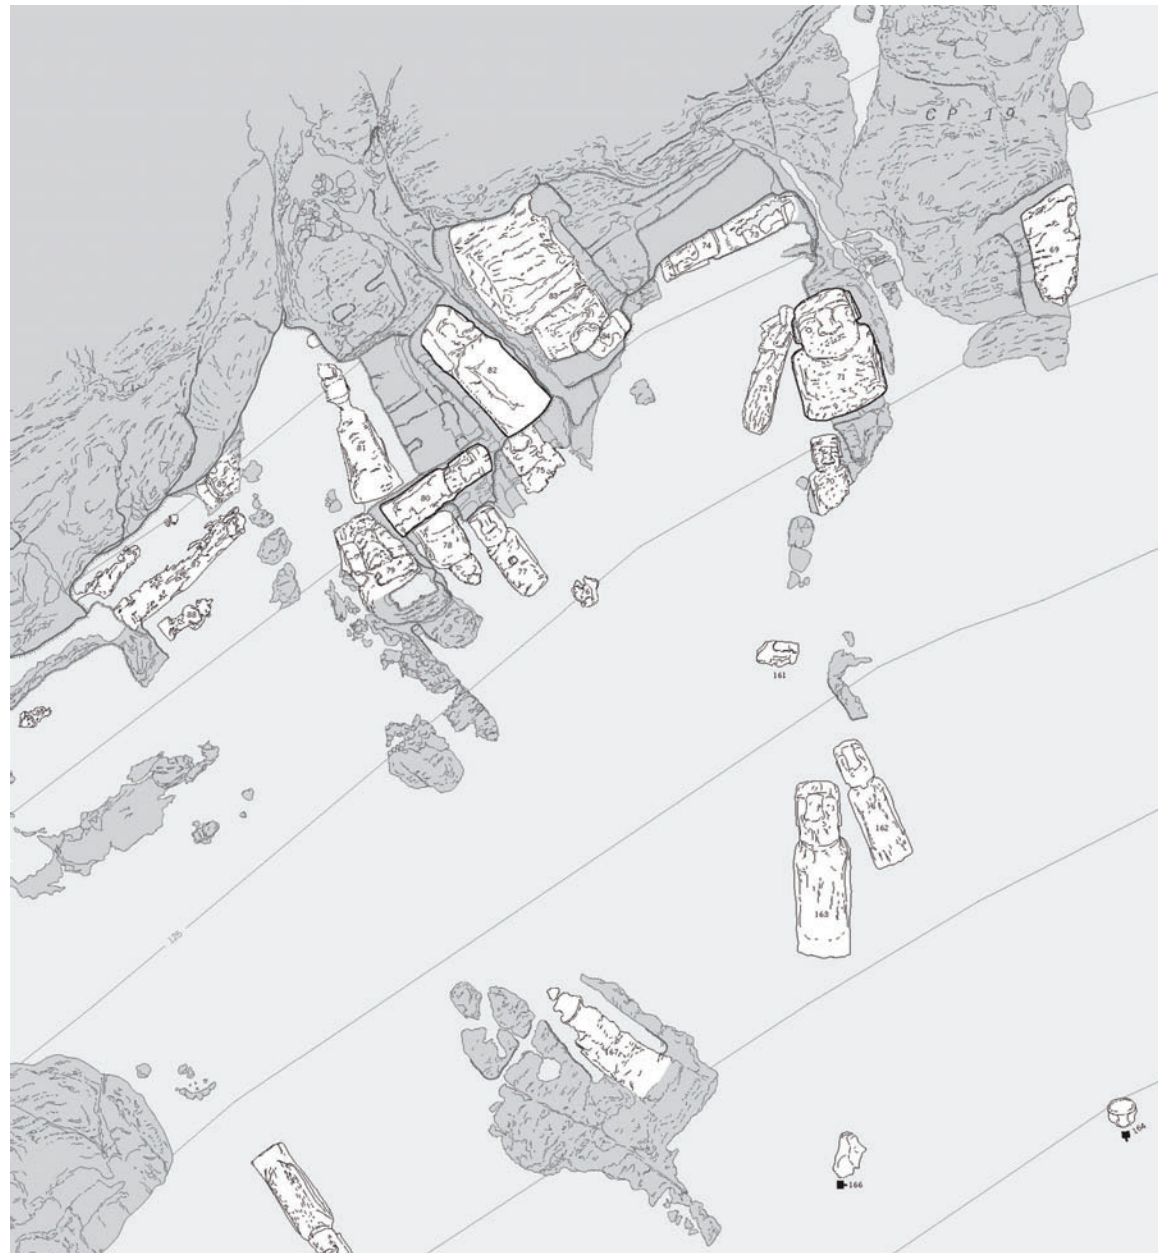
A portion of the finished map, generated from GPS data, showing the location and features of the unfinished moai within the quarry. Diagram: Alice Hom © Jo Anne Van Tilburg/Easter Island Statue Project.

Points were also taken on statues lying on slopes and free of the quarries. Statues standing upright and embedded in the ground lean at various angles from the vertical. Points were taken equidistant in front and behind each of these statues, giving the facing direction as well as the XYZ location. All data were downloaded to a laptop via the infrared connection and the receiver software. GPS points were imported to AutoCAD for manipulation and plotting. The survey was checked on site during data capture and reviewed every night. The data were backed up, archived on the island, and carried back to Los Angeles.

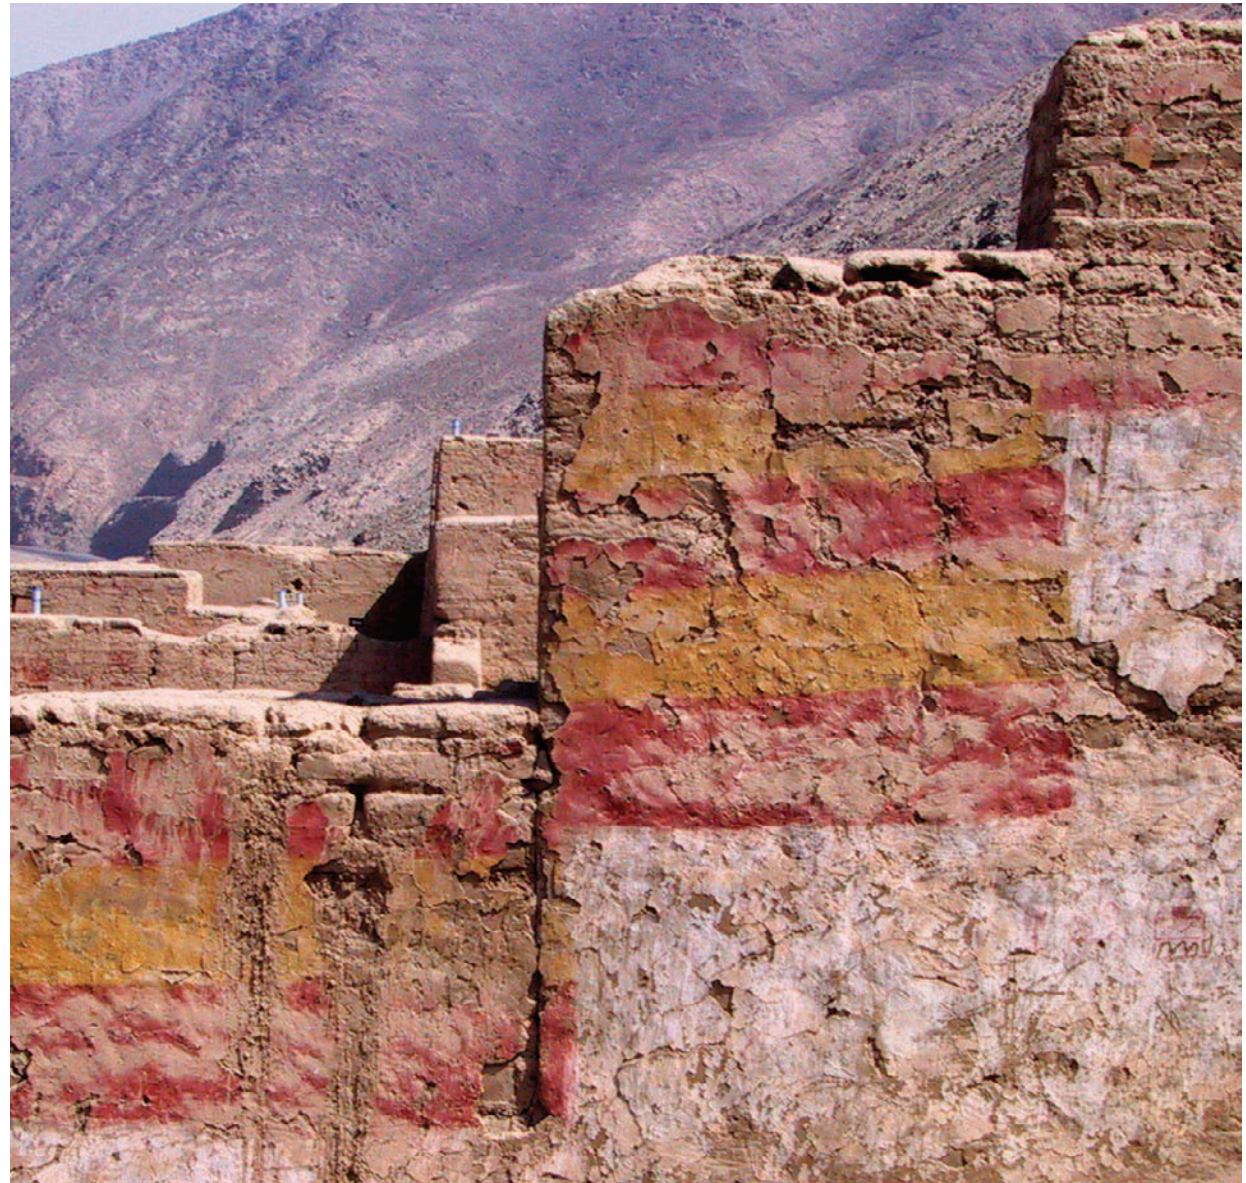
Outer wall of the Northern Palace, showing remnants of the original plaster and paint. Photo: © Alonzo Addison.

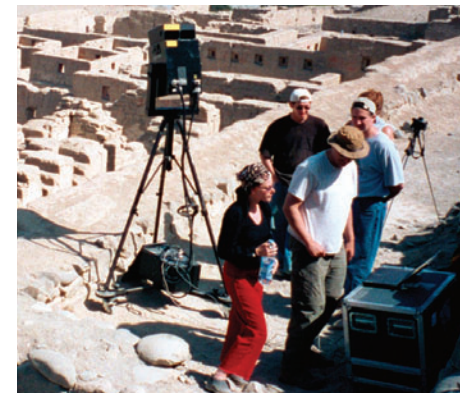
The documentation team at Tambo Colorado preparing to use the Cyrax 2400/2500 (which became the Leica HDS 2500) long-range laser scanner. Photo: © Alonzo Addison.

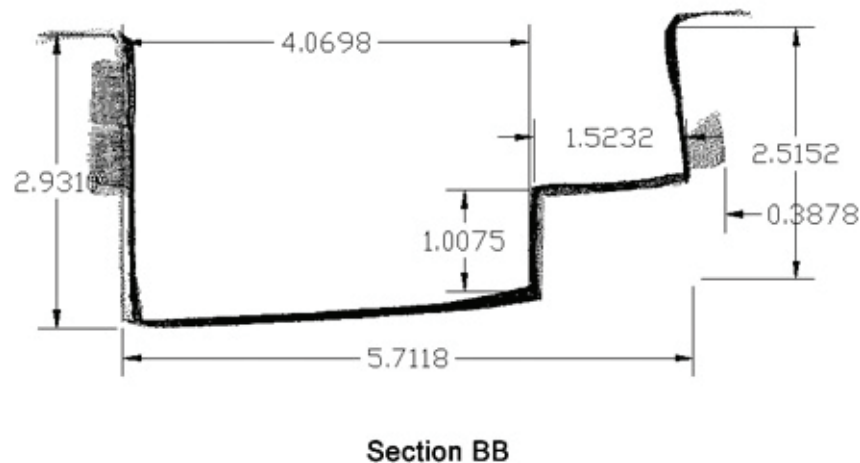
Top: Isolated isometric point cloud of one structure at the site. *Bottom:* A cross section through the isometric point cloud. Images: © Courtesy Center for Design Visualization, UC Berkeley.

Laser scanning provided an ideal solution to record the complex and irregular surface geometry of the remaining adobe walls of this site and its smaller architectural details. As part of an integrated digital tool kit, the technology formed the foundation for a 3-D information archive of current conditions, allowing measurements to be extracted, reconstructions to be visualized, and field notes and photographs to be integrated by location.

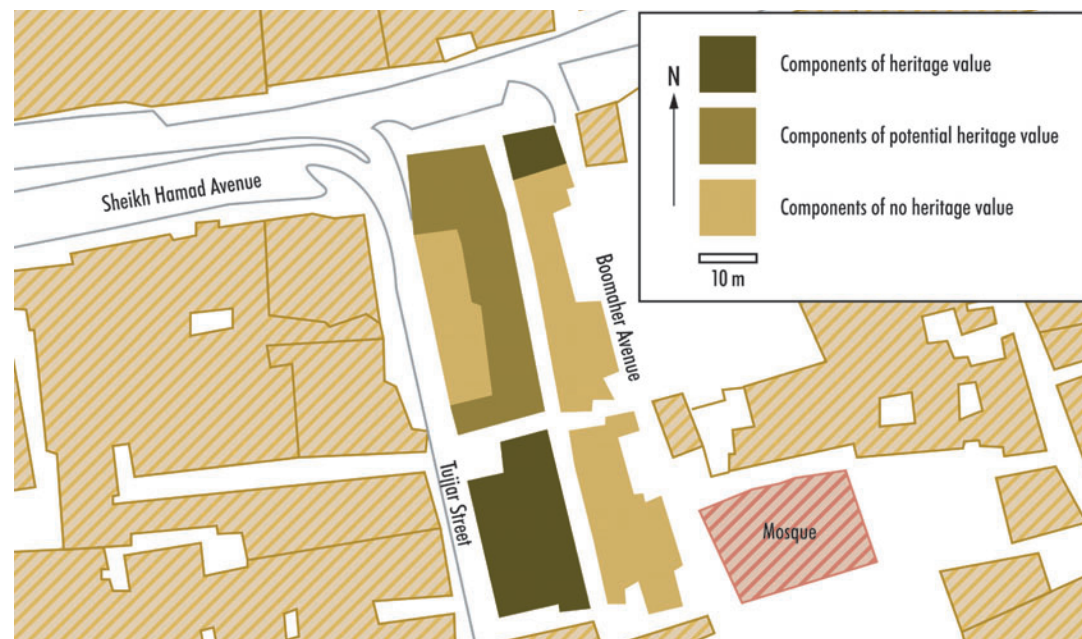
Map of the Qayseriyyah Souq, showing major avenue boundaries, central and auxiliary alleys, and building components of heritage value. Not only are the original visible buildings at risk, but archaeological vestiges are said to be buried within the souq. Map: Steven Rampton.

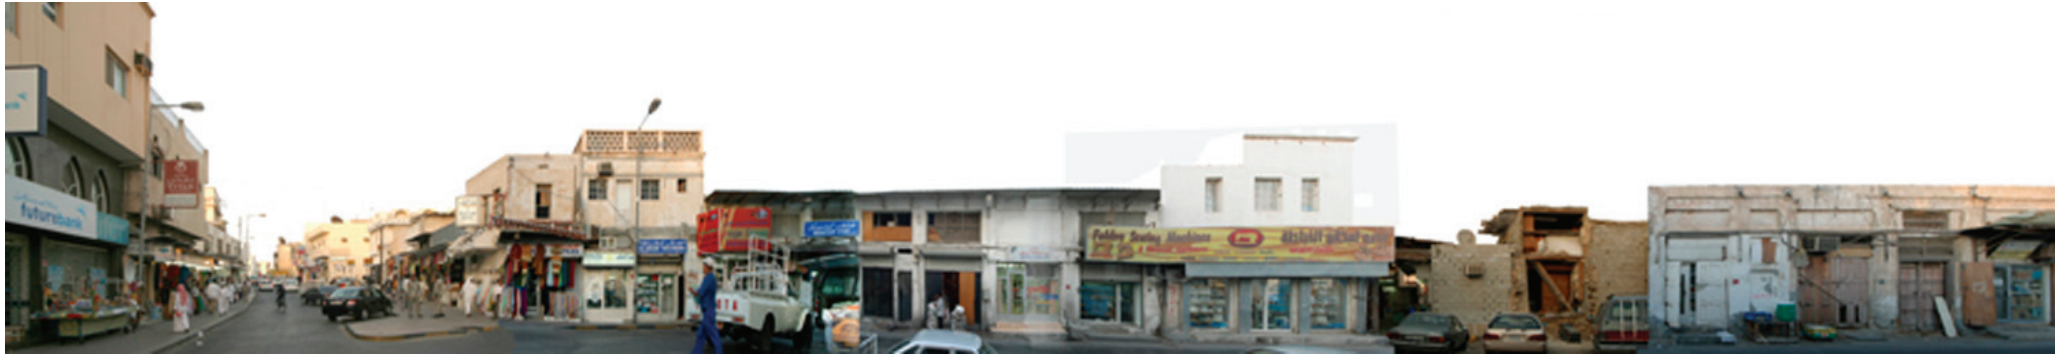
Mosaic of Souq West elevation on Tujjar Street.
Photos: © Salim Elwazani and José Luis Lerma.

Rectified images have several advantages in the field of architecture, urban planning, and conservation. Not only do they provide measurable images of flat surfaces that show surface material conditions, but they also can be stitched together to form an entire facade elevation of a large building or several adjacent buildings. Other recording tools, such as a total station or stereophotogrammetry, can provide some of these results; however, they are time consuming and somewhat expensive, and require specialized training.

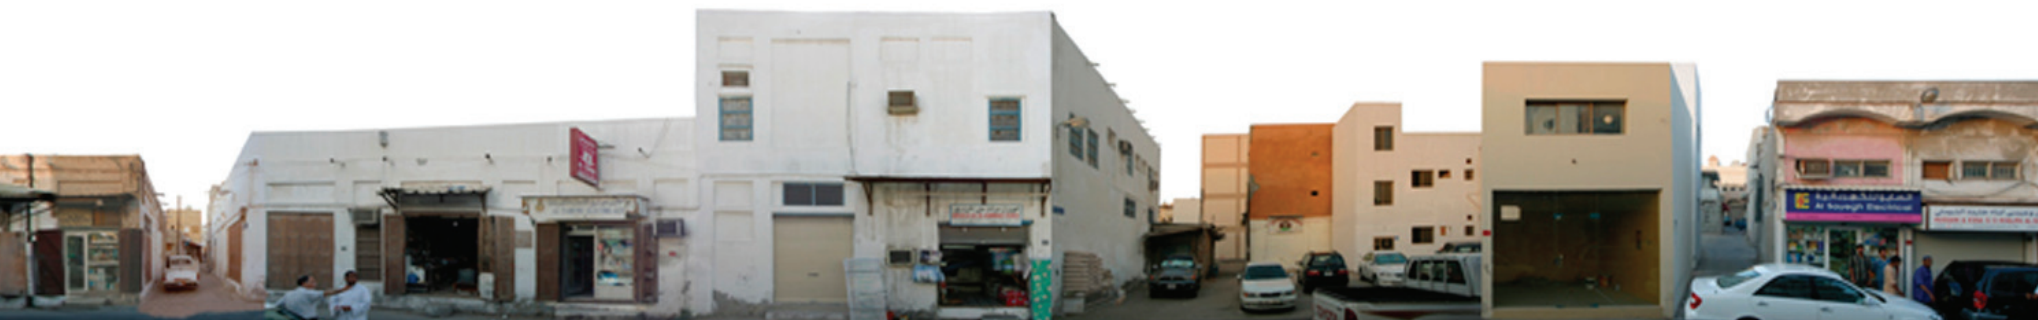
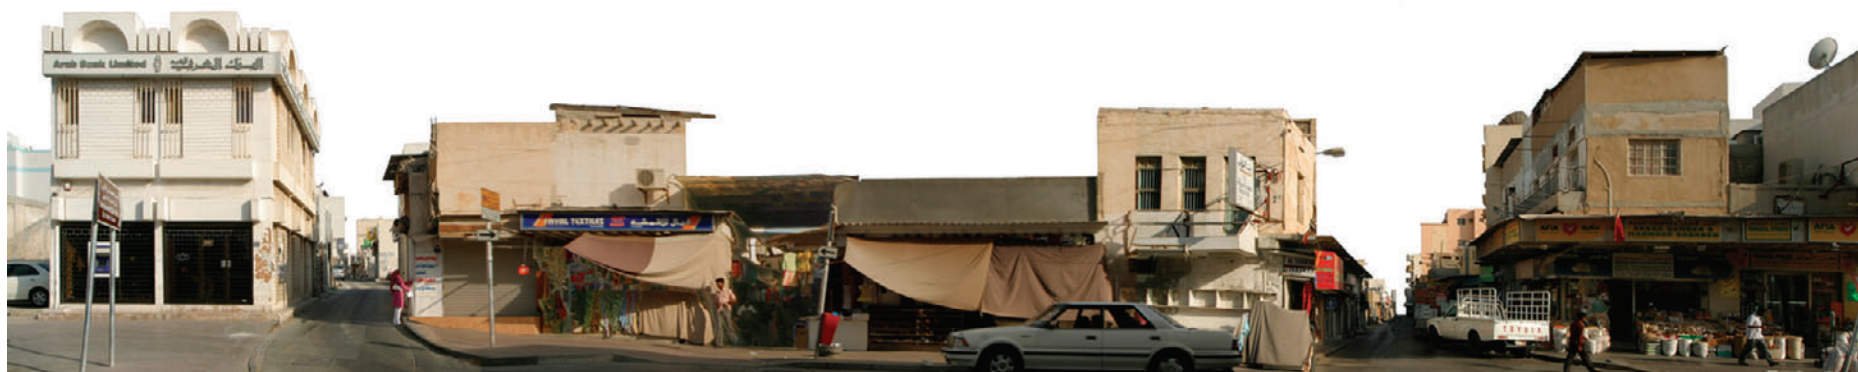
Mosaic of Souq North elevation on Sheikh Hamad Avenue.
Photos: © Salim Elwazani and José Luis Lerma.

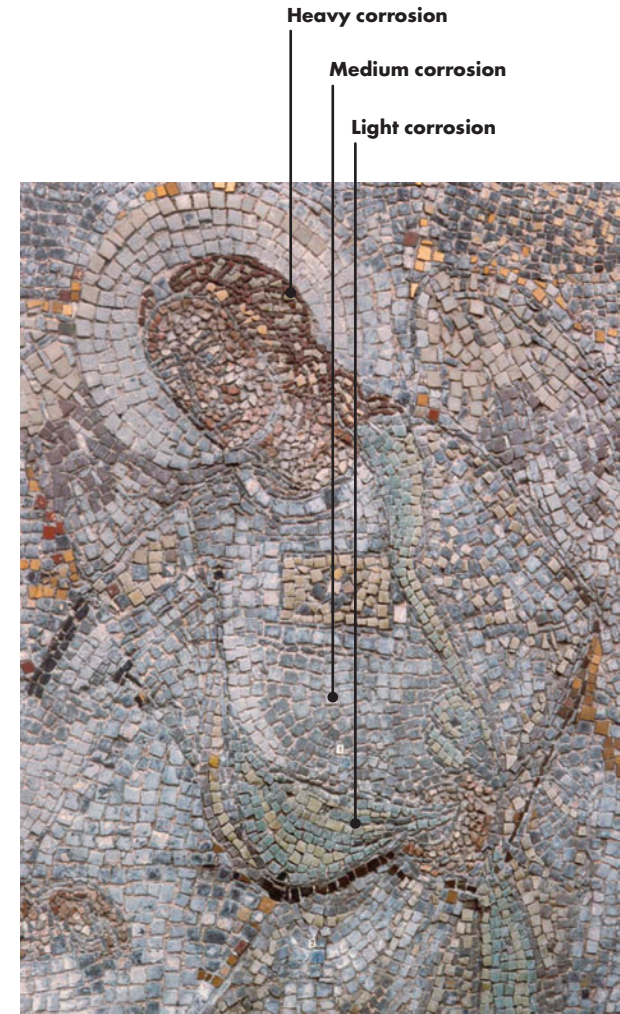
Detail of a figure in the mosaic prior to cleaning, showing levels of corrosion. Photo: Dusan Stulik.

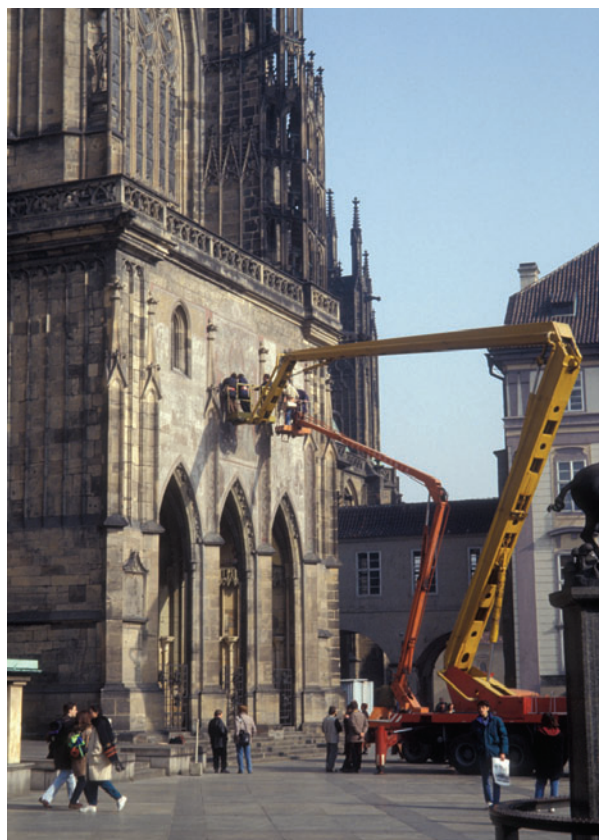
Conservators at St. Vitus Cathedral inspecting the mosaic, recording conditions on transparencies overlaid on rectified photographs of the facade. Photo: Dusan Stulik.

In the third step, the distortion-free images and measurements were imported into AutoCAD, a computer drafting program, and sent to the conservators. Using this program, a grid was then drawn every 20 centimeters over each image, both vertically and horizontally. This, along with a naming standard, created a coordinate system that allowed the team to reference specific sections of the mosaic. For example, Christ passing judgment is located at LJCBC B4. This refers to the *Last Judgment* (LJ), center panel (C), before conservation (BC), column B, row 4. Four rows by four columns were then printed at a scale of 1:4 on A4 heavy-weight paper. A4 transparencies were also printed with a corresponding grid in order to align properly with the image of the mosaic. This proved to be a good size, as it was manageable on a clipboard yet still provided an acceptable level of detail. By using the base map image and transparency overlay, conservators could work on the scaffolding to manually record important features.

Information collected by conservators on the transparencies was scanned and imported back into the computer model. Prior to collecting information on the transparencies, it was found that certain colors—green, yellow, and other light colors—were not optimal for scanning. Therefore red, dark blue, black, brown, magenta, and orange were chosen for use. It was also important that only

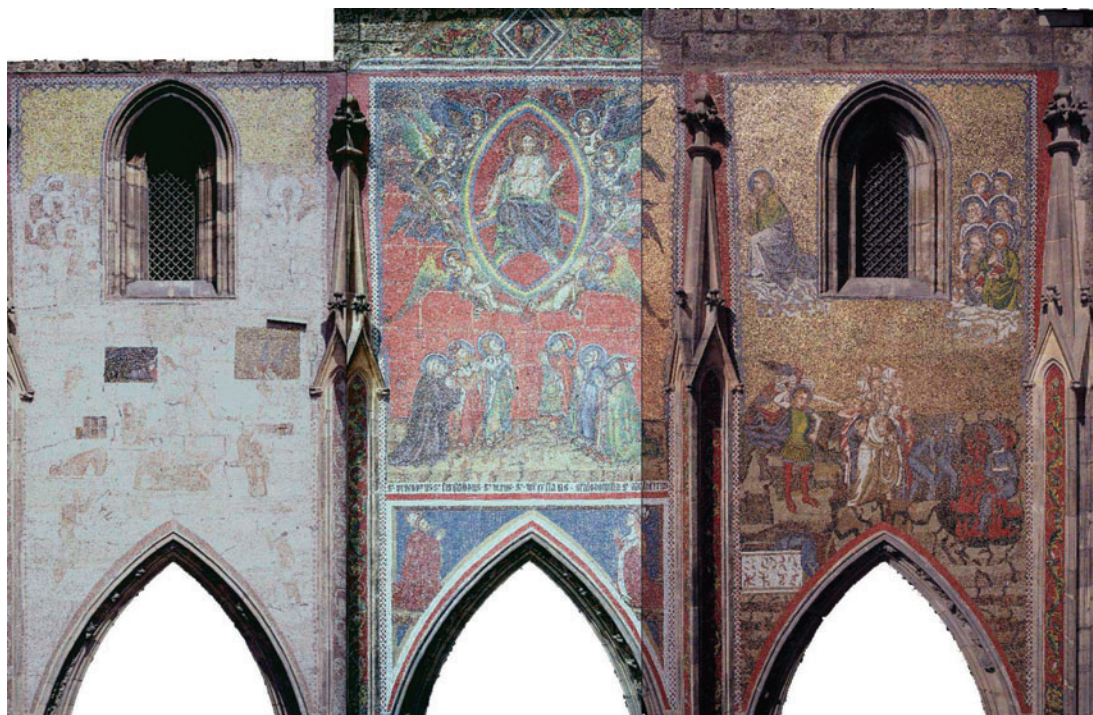
Rectified images of the facade, showing its state before conservation (*left*), after treatment (*center*), and after gilding (*right*). Images: Jaroslav Zastoupil.

PhoTopoL, the digital images were then rectified, or transformed, and correlated to fit actual dimensions of the mosaic. The removal of distortion and the placement of the images to exact scale were crucial, as each of the three panels was photographed separately during different phases of the work. This allowed images taken before, during, and after conservation of each panel to align exactly.

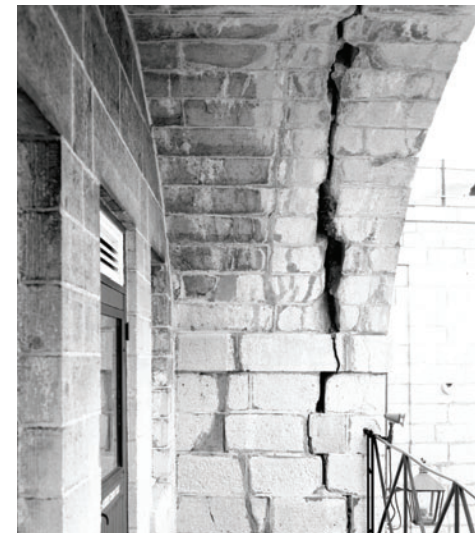
Fractures and spalling of the limestone blocks in an archway of the redoubt. The mortar joints had also deteriorated significantly. Photo: © Fort Henry National Historic Site of Canada–Archives.

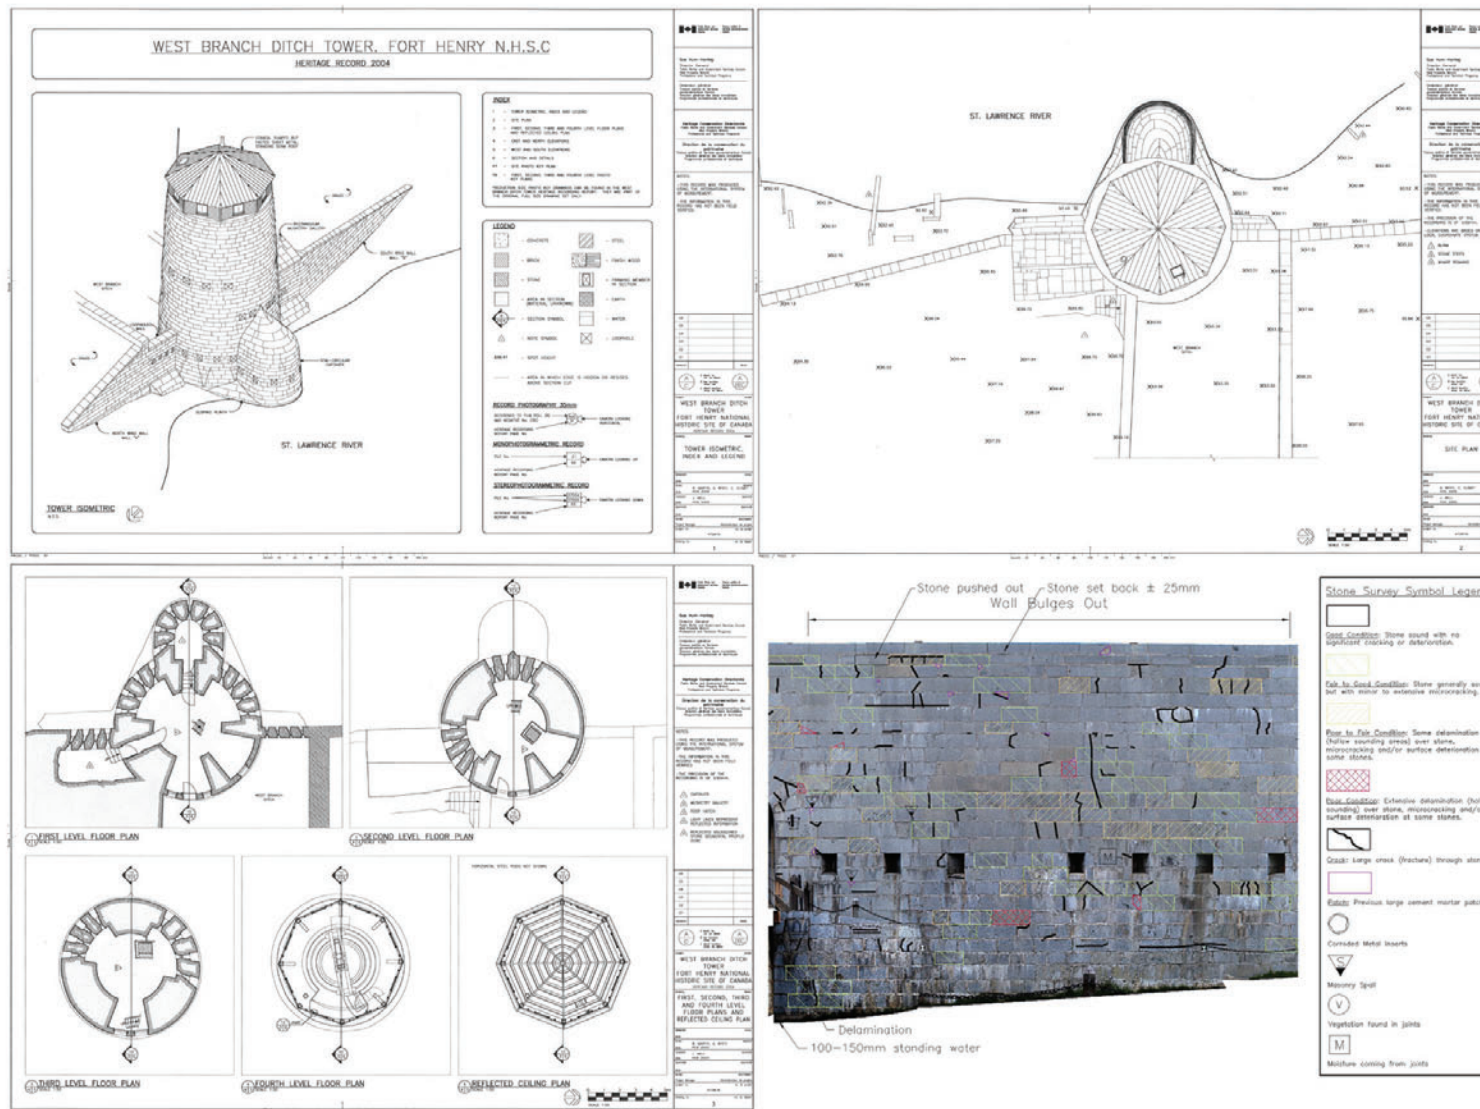
Elevation and section drawings of the West Branch ditch tower. Included is the condition survey of the facade masonry and mortar. Drawings: Christian Ouimet © Heritage Conservation Directorate, Public Works and Government Services Canada.

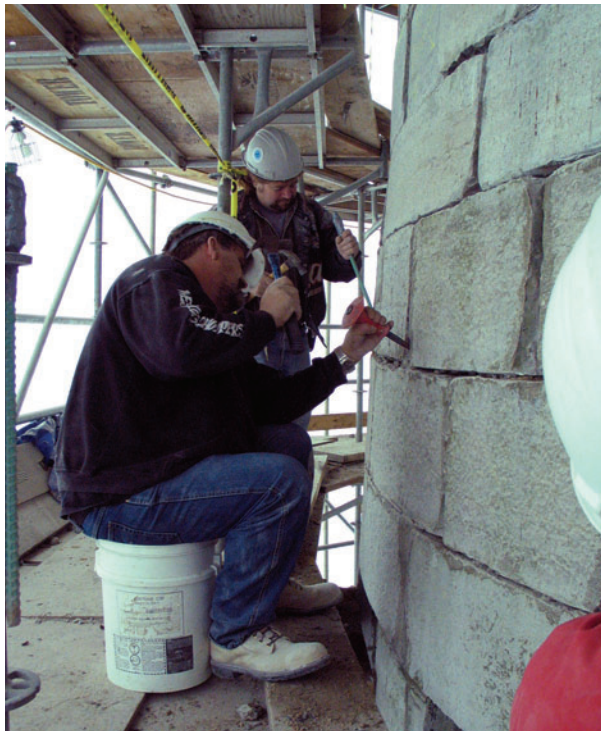
Workers removing deteriorated mortar from the East Branch ditch tower for repointing. Photo: © Fort Henry National Historic Site of Canada–Archives.

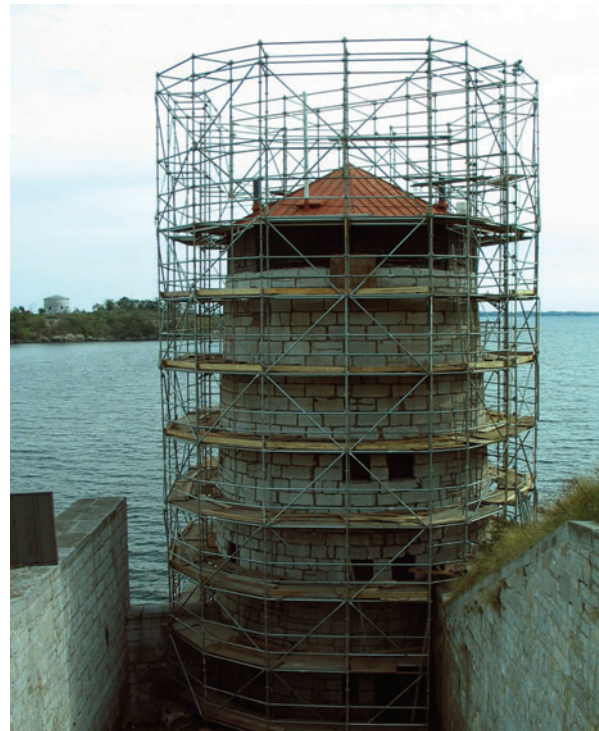
The scaffolded East Branch ditch tower during the restoration project. Photo: © Fort Henry National Historic Site of Canada–Archives.

project commenced in 2004 to waterproof, repair, and stabilize the redoubt, and in fall 2006, conservation work was begun on the East Branch ditch tower to restore the roof and repair the stone walls. This work continues in 2007 on the West Branch ditch tower. Other conservation projects currently in the planning and implementation stages include the repair and repointing of the advanced battery and the north wall of the redoubt. Each intervention reflects a commitment to respecting the established heritage character of the site.

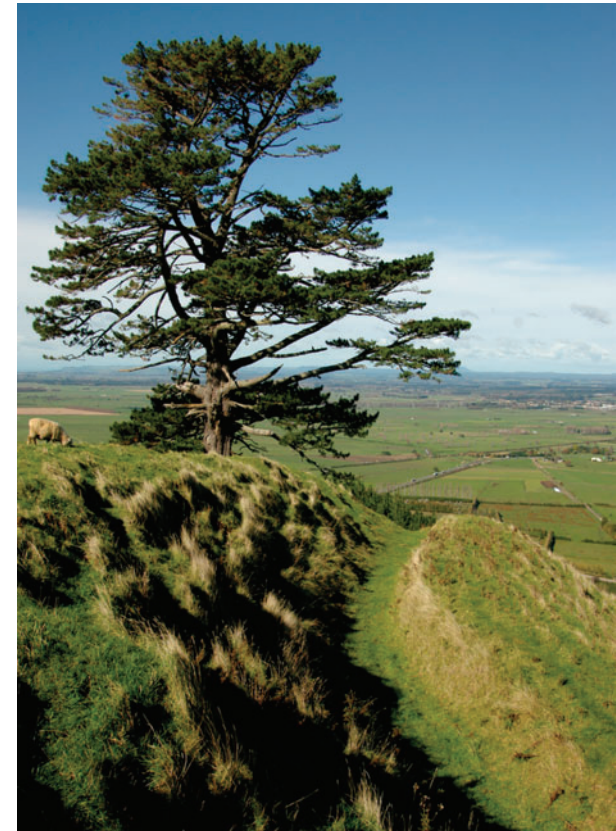
Prominent lateral defensive ditch and terracing on Karangaumu pā. Photo: Kevin L. Jones © New Zealand Department of Conservation.

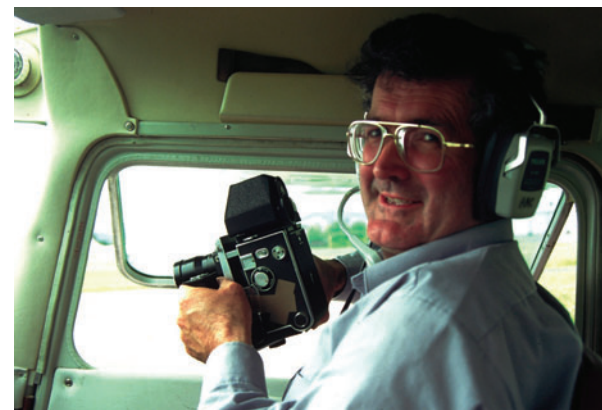
The author preparing to take oblique aerial photographs of pā on the North Island of New Zealand. Photo: Kevin L. Jones © New Zealand Department of Conservation.

centimeter) film cameras or a high-resolution (10 megapixel) digital single lens reflex (SLR) camera. Oblique images have many advantages for mapping and monitoring areas of the size of most archaeological sites or building complexes. Although more difficult to map or scale because they are not vertical, they are nevertheless sufficient in that they reveal many details and conditions of earthwork archaeological sites and can cover areas up to 600 meters across. They are particularly effective in monitoring sites over time and can cover numerous sites (fifty or more) in the course of one well-planned flight lasting two to three hours. The cost per site monitored is lower than visiting remote sites as part of a vehicle-based ground crew, where access may take as long as two to three hours, and the number of sites visited per day would seldom be more than ten.
