Recording, Documentation, and Information Management for the Conservation of Heritage Places

ILLUSTRATED
EXAMPLES

Rand Eppich, *Editor*

The Getty Conservation Institute

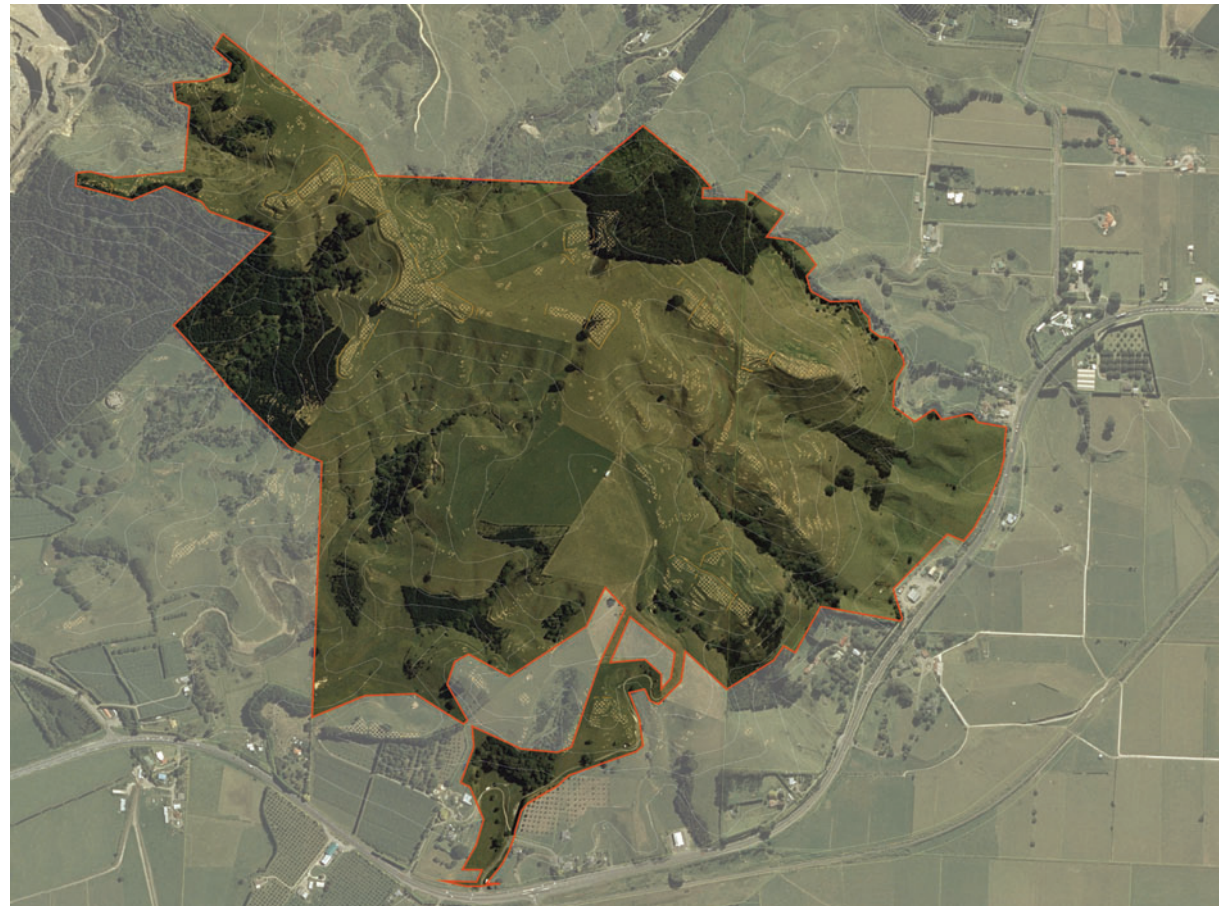
Orthophotographic aerial photography of the entire Papamoa Hills Regional Park. Photo: Fugro Airborne Surveys © Environment Bay of Plenty, New Zealand.

The interpretation of the aerial imagery of the Papamoa Hills guided the conservation recommendations for the management plan of the park. The aerial images of Karangaumu pā, to the west of the site, revealed several conservation issues: a farm road had been bulldozed through the pā from the southeast along the lateral ditch and bank defenses; gates, water tanks, and fences on the northern platform concentrated grazing sheep, leading to erosion; gullies on the northwest side have slowly eroded the slope; and minor erosion has resulted from people walking on the main platform down to the central transverse ditch area.

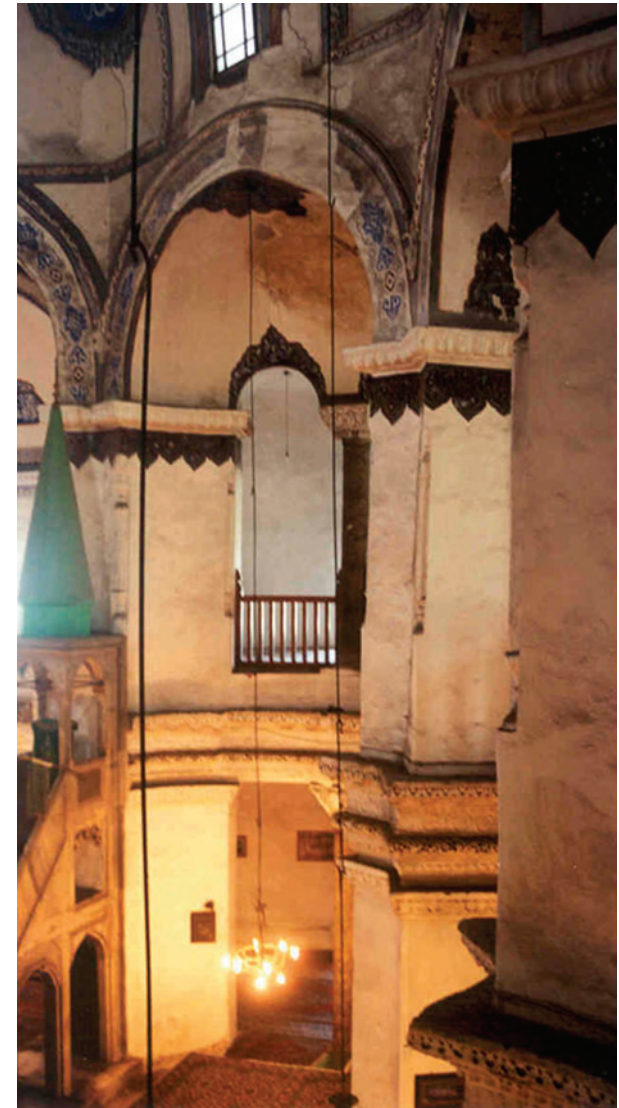
Interior view of pillars supporting the dome of Küçük Ayasofya. A free-hanging line indicates how far the center pillar is out of plumb. Photo: C. Gerstenecker © Küçük Ayasofya Project.

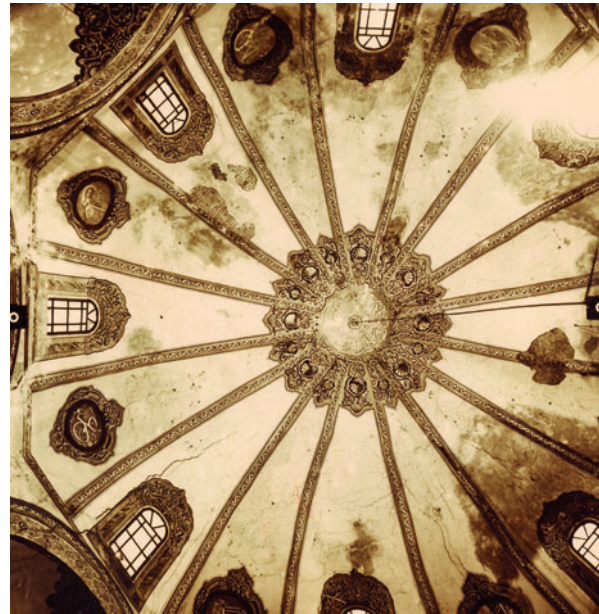
A pair of stereographs of the dome, taken looking straight up. Note the large number of cracks. Photo: A. Alkiş © Küçük Ayasofya Project.

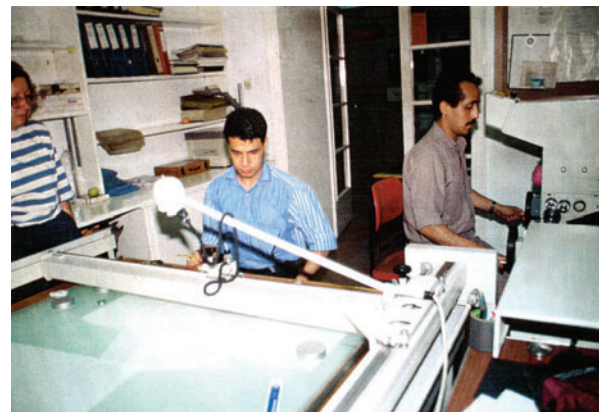
The documentation of Küçük Ayasofya was carried out in three phases by three or four experts, a technician, and two trained students. First, in 1994, the geometry of the dome was accurately documented. Targets were placed on the pillars and walls of the gallery. Over the course of two days, forty stereographs were taken of the dome using a Zeiss UMK 1318 universal wide-angle metric camera. This model was chosen because of the height of the dome. In addition, control points were measured with a total station theodolite, an instrument that computes vertical and horizontal angles. The photographs were produced from glass plates and processed in the laboratory. A contour map was then generated using a Zeiss Topocart D stereoplotter. A stereoplotter optically projects a 3-D image of the pairs of stereographs. From this image, contour lines are traced, thereby providing an accurate topographic model from which to extract measurements. The model was created in two weeks and manually digitized in ten days.

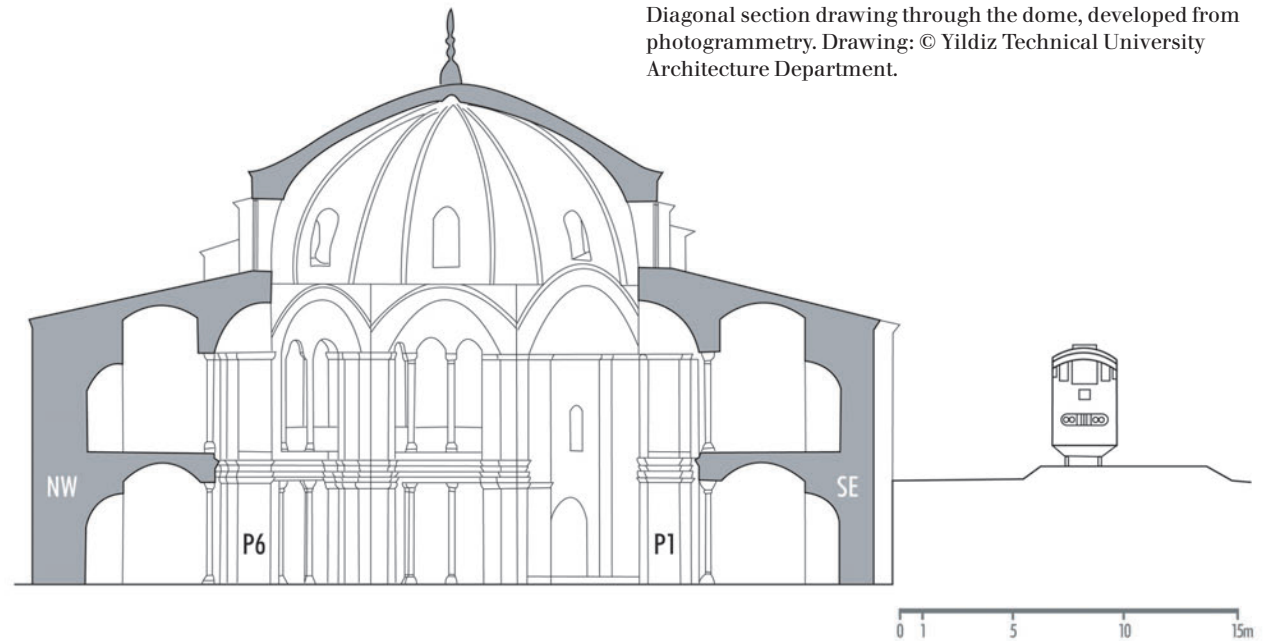
Diagonal section drawing through the dome, developed from photogrammetry. Drawing: © Yildiz Technical University Architecture Department.

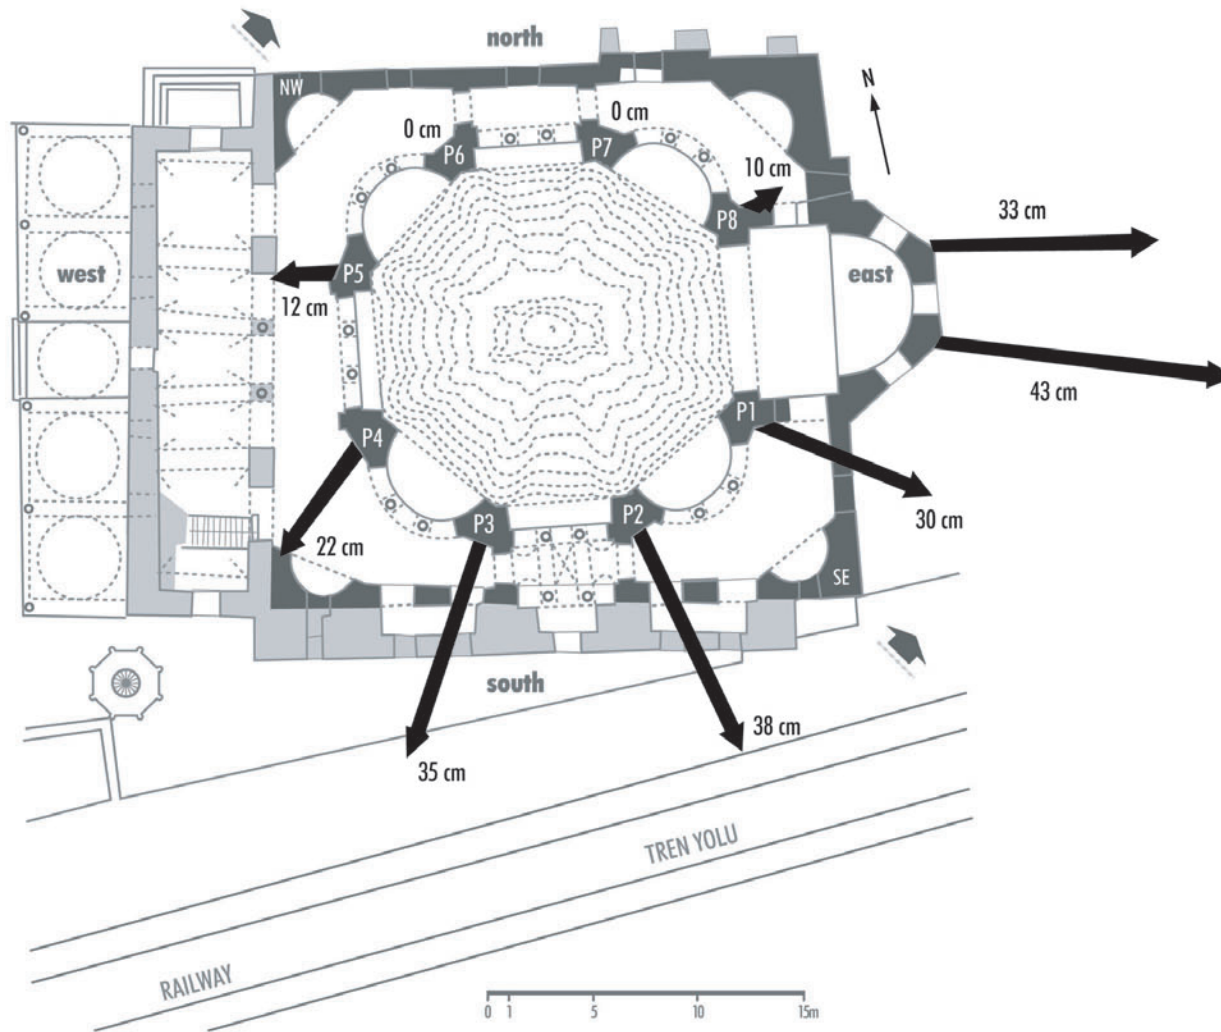
Floor plan and topography of the dome, acquired from photogrammetry. Vectorized column displacement identifies both the direction and distance that vertical structural members have shifted. Drawing: © Yıldız Technical University Architecture Department.

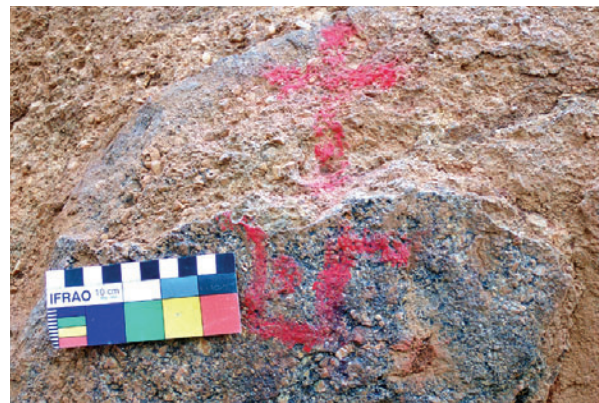
Red graffiti obscuring rock art at Uluru.
Photo: © Mick Starkey.

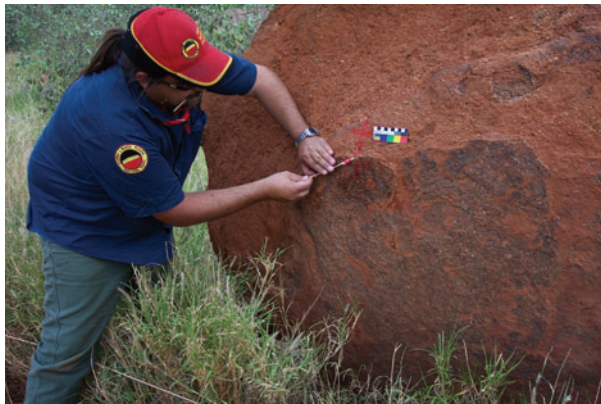
A conservation team member removing graffiti at Uluru.
Photo: © Cliff Ogleby.

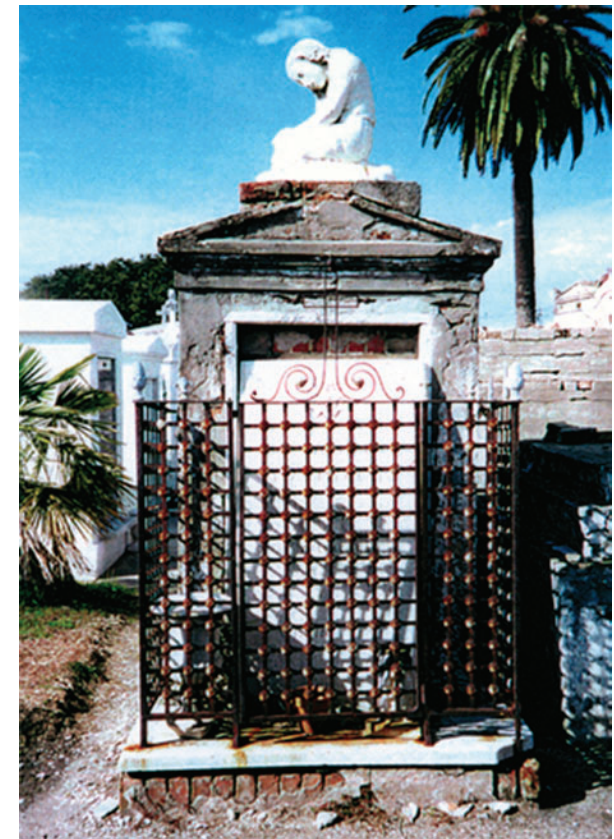
The Bergamini tomb, dated 1865, showing areas of loss as well as soiled and weathered marble. Photo: Frank Matero
© University of Pennsylvania Architectural Conservation Laboratory.

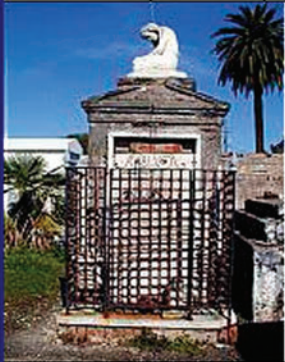
Example of a typical partial record created in Microsoft Access. Courtesy Judy Peters © University of Pennsylvania Architectural Conservation Laboratory.

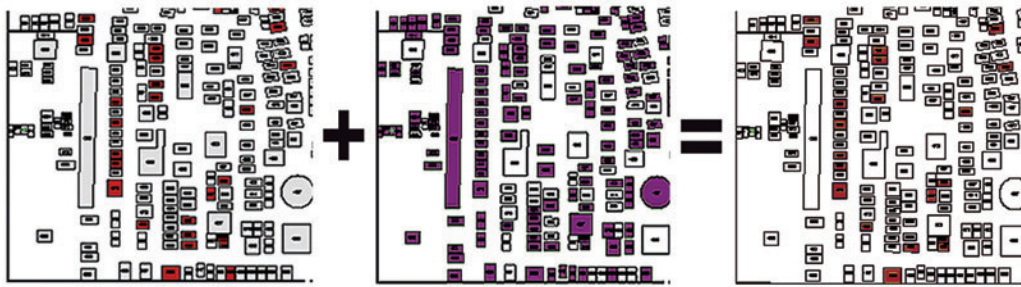
GIS can be queried to add maps together. A query for tombs in a poor state of conservation (*left*) can be combined with or added to a query for tombs of high significance (*center*) to provide a map of tombs that must be worked on first (*right*). Maps: © University of Pennsylvania.

GIS provided visualization and analysis of the site over time and through any combination of criteria recorded in the survey to analyze conditions of the tombs and to prioritize conservation interventions. Once data became available to the digital map, material, condition, and significance attributes could be visually and quantifiably analyzed through queries and calculations. Using the graphic mapping interface, data were analyzed interactively and presented in dynamic map layers for both assessment and presentation purposes. Conditions were sorted, mapped, and mathematically combined and compared with many factors such as urgency, location, material, and cost. Interactions between conditions yielded new visual information for determination of root causes. Through the built-in database, extensive reports, summaries, and graphs were generated. These tools ensured that the conservation plan was based on a combination of qualitative and quantitative values.

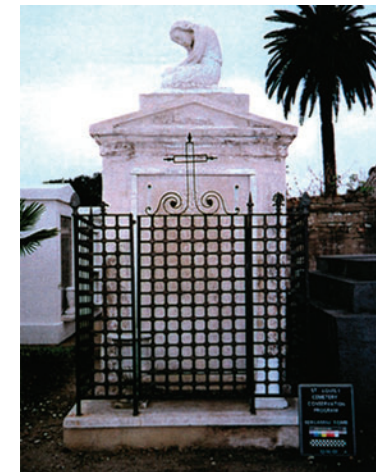
The Bergamini tomb, after restoration. The masonry and associated stone and metalwork were stabilized and conserved. Photo: Frank Matero © University of Pennsylvania Architectural Conservation Laboratory.

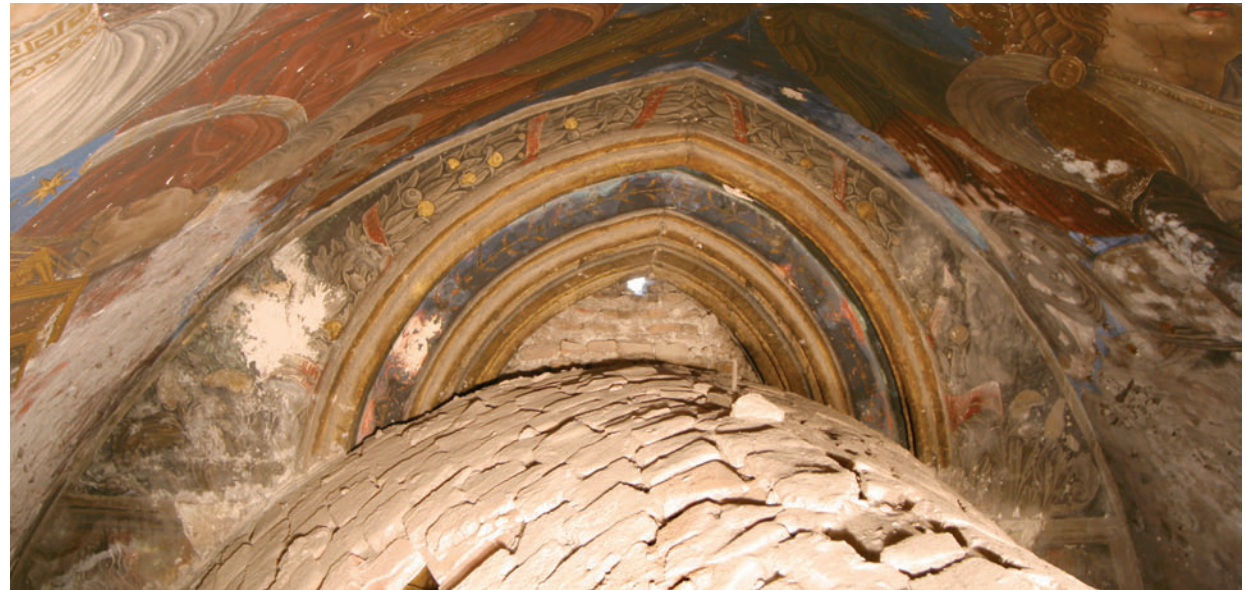
The void between the domes inside the cathedral. The space was too narrow to view the paintings in their entirety. A camera inserted into the space was able to capture multiple details for later compositing of the entire scene.
Photo: © José Luis Lerma.

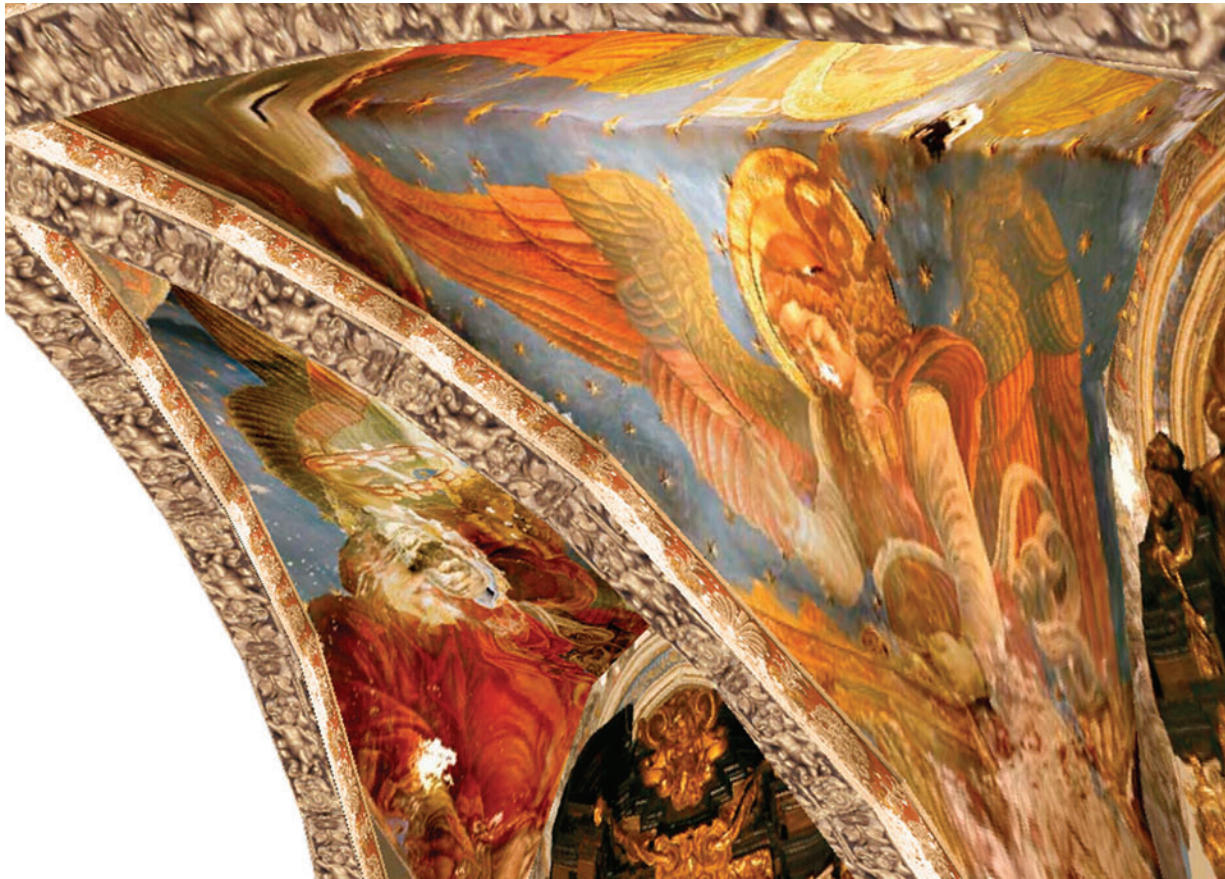
Construction of the 3-D digital model required mapping the images to their positions on the digital structure. Photo: © José Luis Lerma.

A wire frame model over which the composite image of the entire scene was draped. Drawing: © José Luis Lerma.

The pictures of the curved surface of the frescoes were foreshortened. In order to create a distortion-free flat image, the images were projected onto the curved surface of a 3-D model. This model could then be unrolled to provide a 2-D image. 3-D modeling was also preferred because data could be collected quickly in the field using handheld instruments. The gathered information was relatively accurate and had good resolution. The modeling software package was inexpensive and easy to use, and the final model allowed the user to view the vault from different angles and visualize different conservation scenarios.

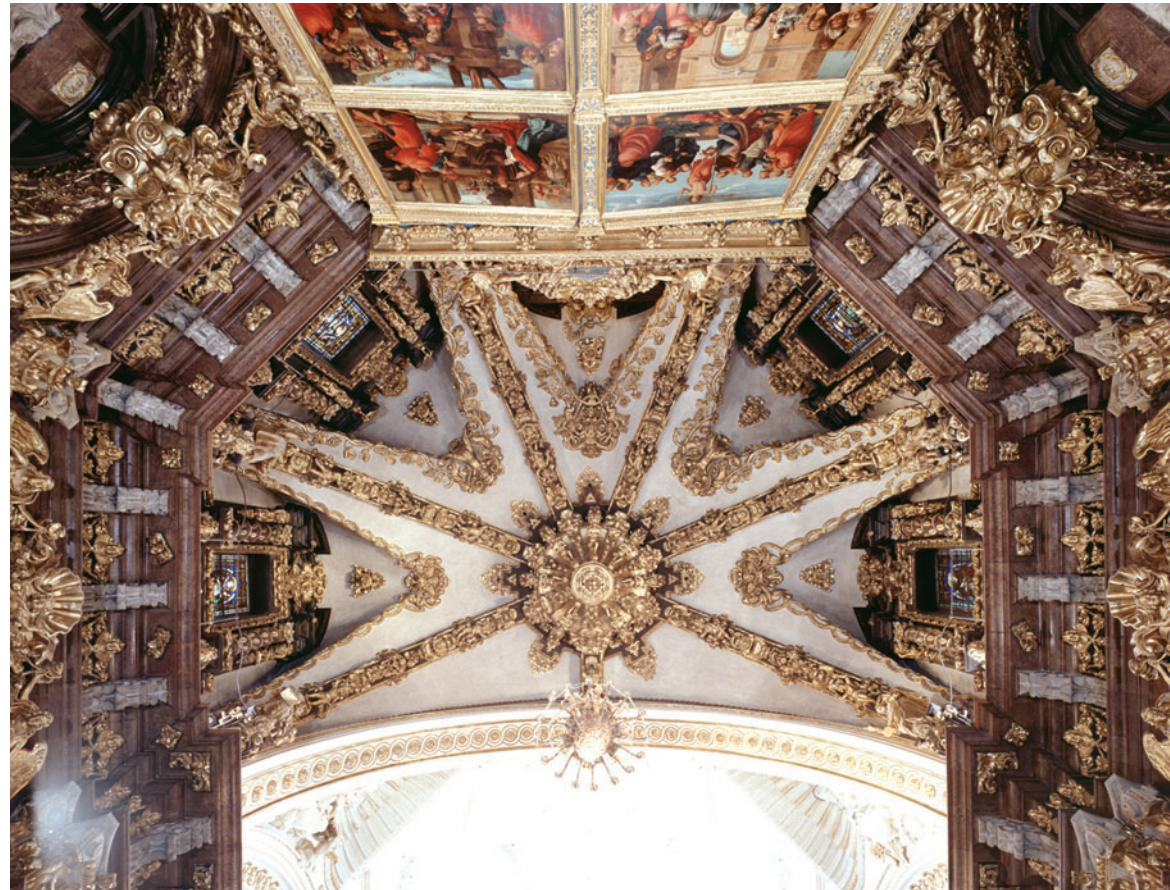
The cathedral's Renaissance dome, before the removal of the baroque vault. Photo: © José Luis Lerma.

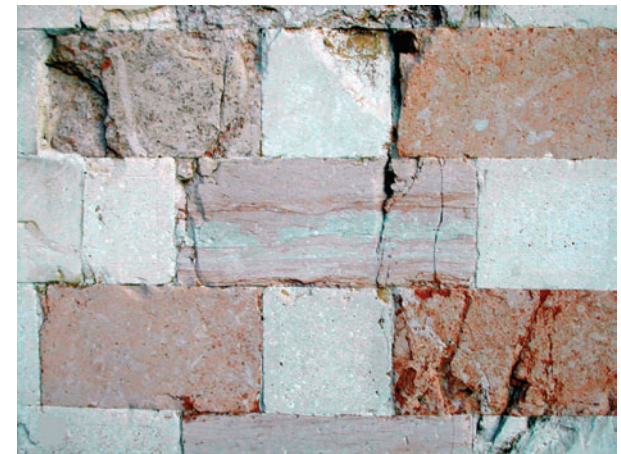
Detail showing the masonry deterioration of the facade caused by seismic stress. Photo: © Marco Tallini.

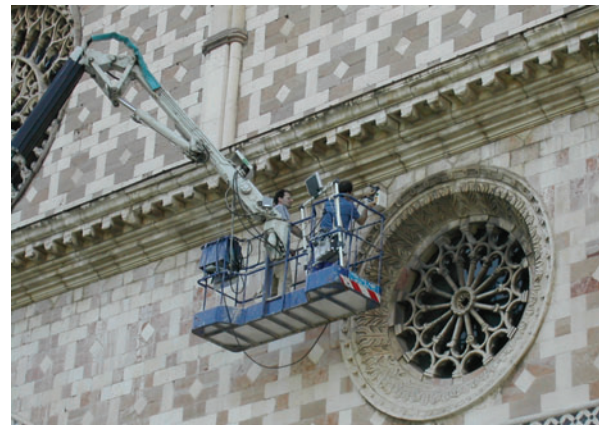
Technicians using GPR for data acquisition near the basilica's rose window. The GPR system was applied directly to the building's surface. Photo: © Marco Tallini.

GPR was more appropriate for this study because it is a nondestructive technique that requires little contact with the medium. In addition, this tool has a good level of accuracy and is easy to handle and transport. GPR testing was therefore used in order to understand the internal masonry structure of the facade by determining the thickness of the wall, to locate cracks and areas of detachment, and to identify where consolidation treatment was needed.

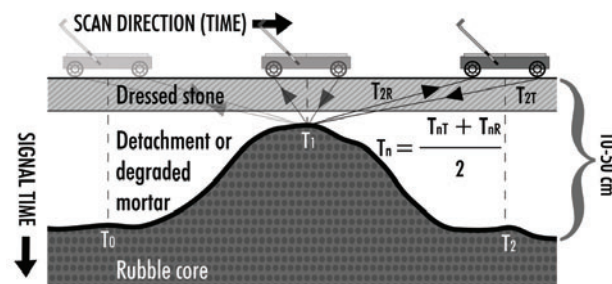
During GPR acquisition of data, a point-shaped target generates a hyperbole-shaped radar anomaly. Drawing: Steve Rampton.

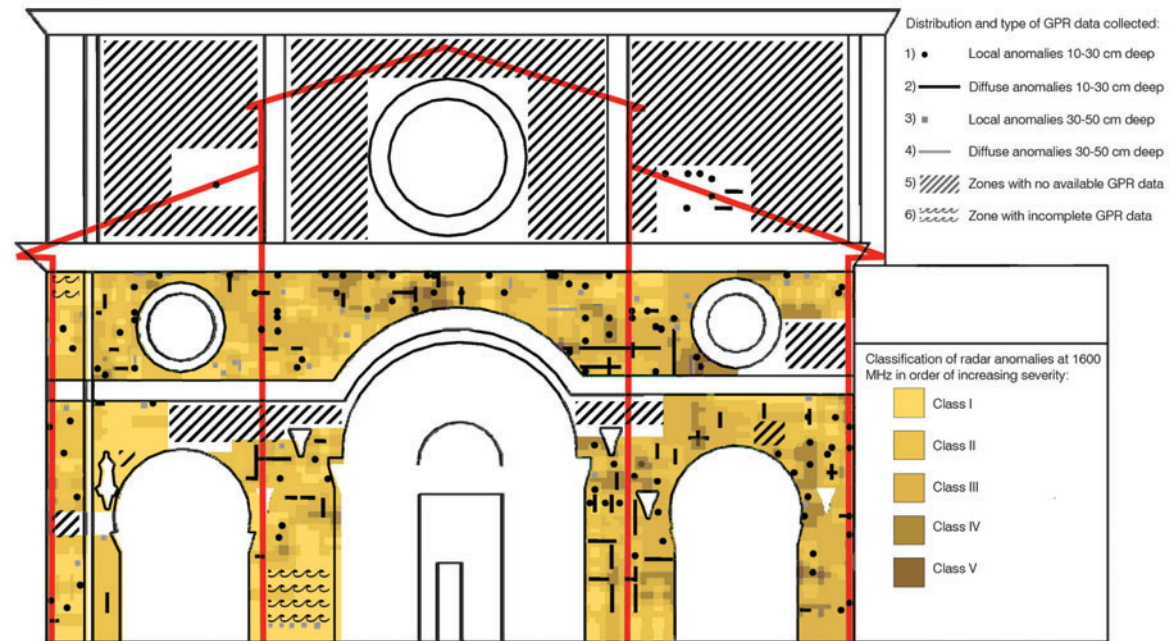
Diagram of the basilica, showing radar anomalies (1600 MHz) after filtering and rasterizing. Colors show anomalies classified according to increasing gravity (classes I–V). Diagram: © Marco Tallini.

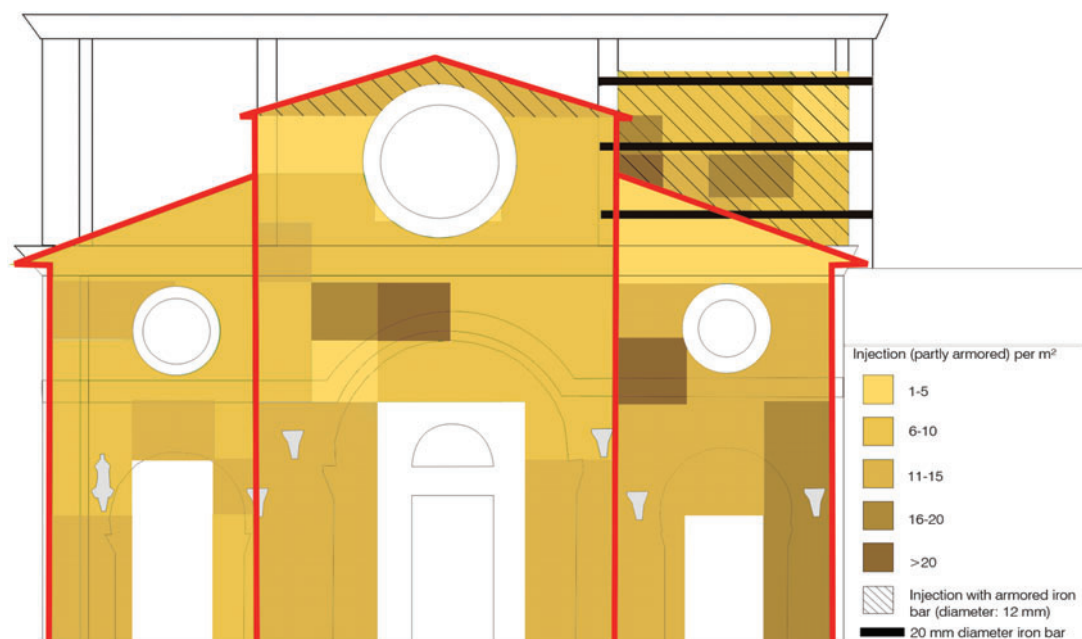
Treatment plan for the facade, implemented in spring 2005 based on conditions mapped in previous diagrams. Colored areas are related to the increasing density of the grout. In some cases, injections were combined with the insertion of 12-mm-thick stainless steel. Diagram: © Marco Tallini.

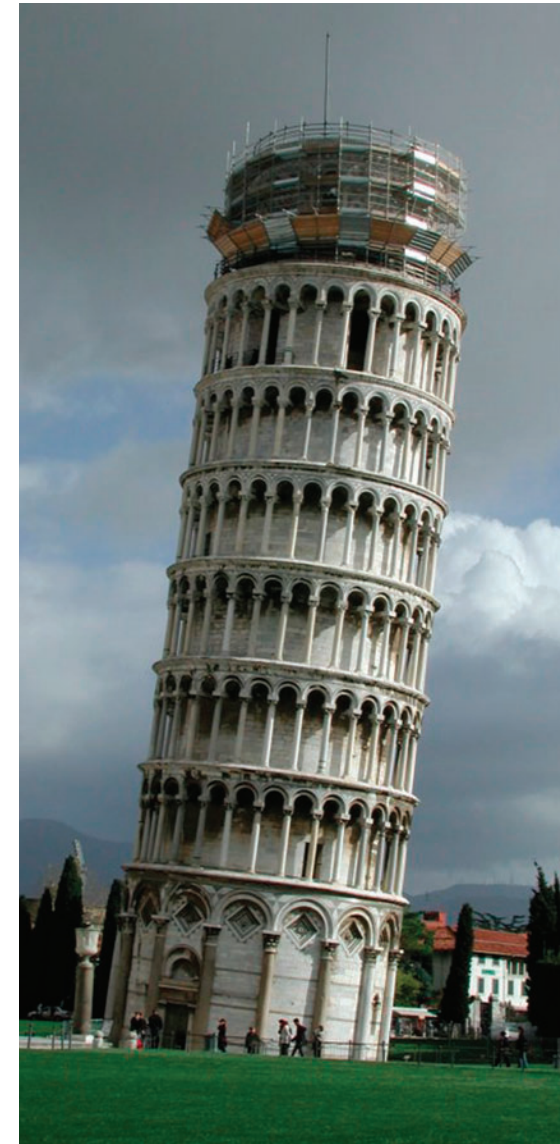
The Tower of Pisa in 1993, with its belfry under conservation during the preliminary stabilization phase. Photo: © Gary Feuerstein, 1993.

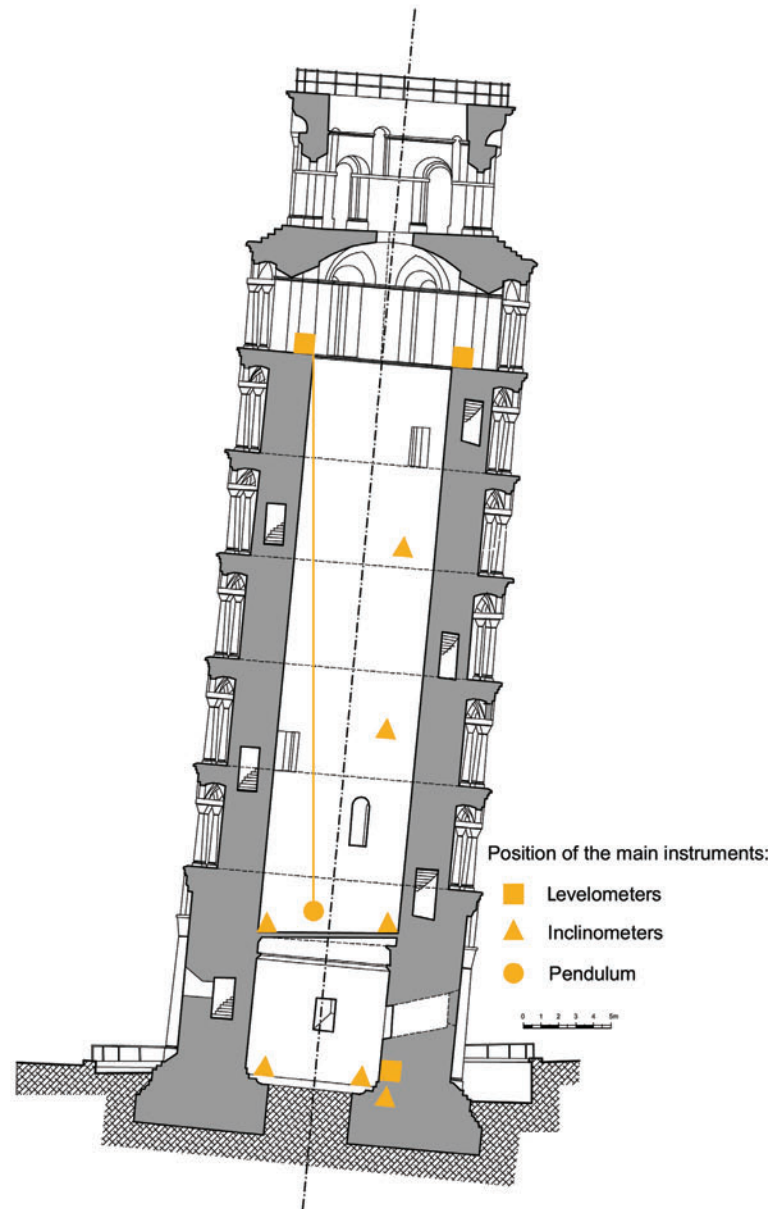
The placement of devices throughout the tower provides a picture of the structure's overall condition. Drawing: © Giorgio Croci.

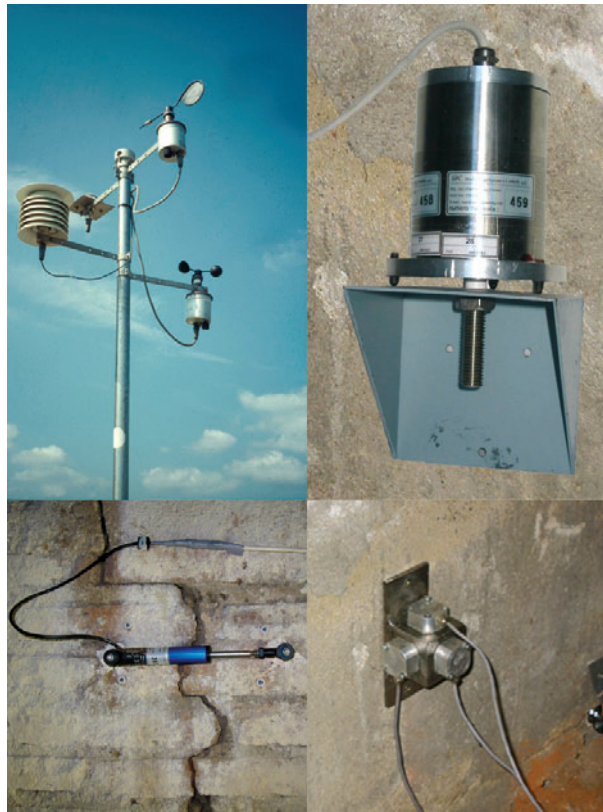
Clockwise from top left: weather station; biaxial inclinometer, which measures tilt in both north–south and east–west directions; accelerometers, which measure three-axis seismic acceleration; transducers, which measure strain on cracks. Photos: © Giorgio Croci.

movement is due to a strong wind, a sunny day, or, more important, their intervention or an impending failure. A weather station was positioned on top of the tower to record wind direction and speed, ambient temperature, and radiation from the sun. Thermometers were placed inside the masonry on different floors to correlate deformations of the structure with temperature. These measurements record how the structure reacts to environmental forces and were useful before and during work on the tower.

Cracks are also typical in masonry buildings, especially in towers eight hundred years old. They can be beneficial by relieving stress but also can be a warning sign of more serious issues. Strain gauges were installed to measure crack propagation or reduction in twenty-five different locations. These highly sensitive instruments were affixed to the cracks and essentially converted mechanical motion into an electronic signal. The gauges were calibrated to take into account temperature changes and other material properties. As with environmental measurements, the crack monitors served to inform the engineers as they conducted their studies and made changes to the tower.

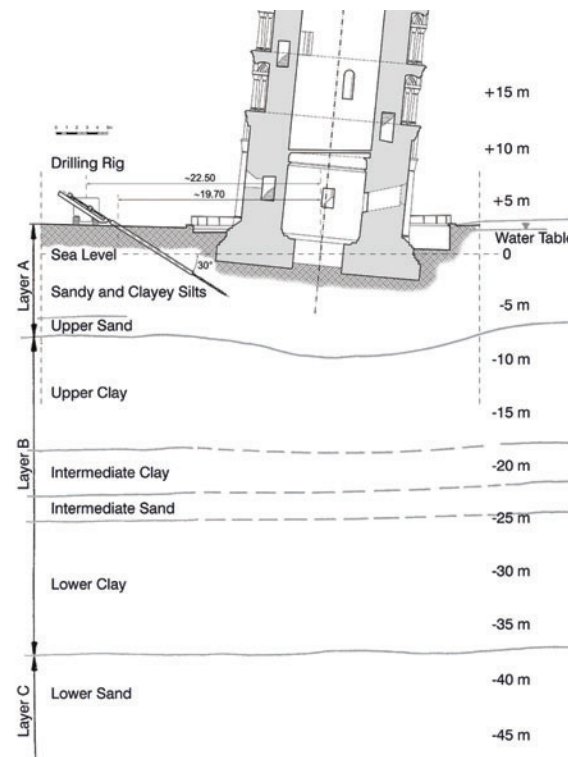
Drilling allowed the strategic removal of clay from the subsoil under the tower's foundation. Drawing: © Giorgio Croci.

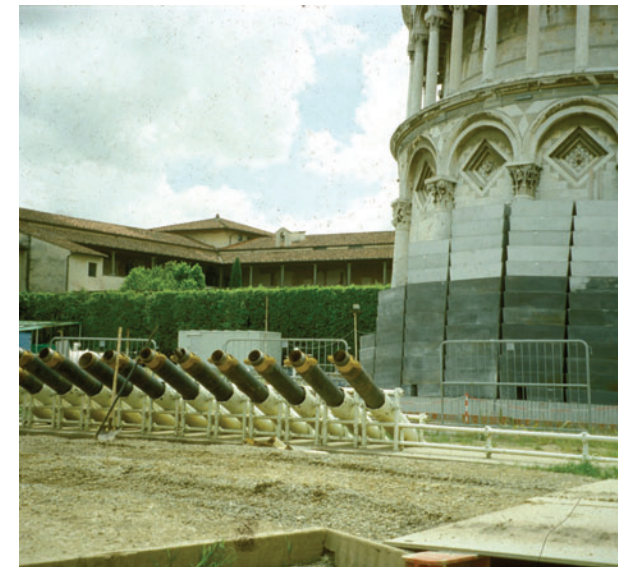
Lead weights were used to reduce the tower's lean. Photo: © Giorgio Croci.

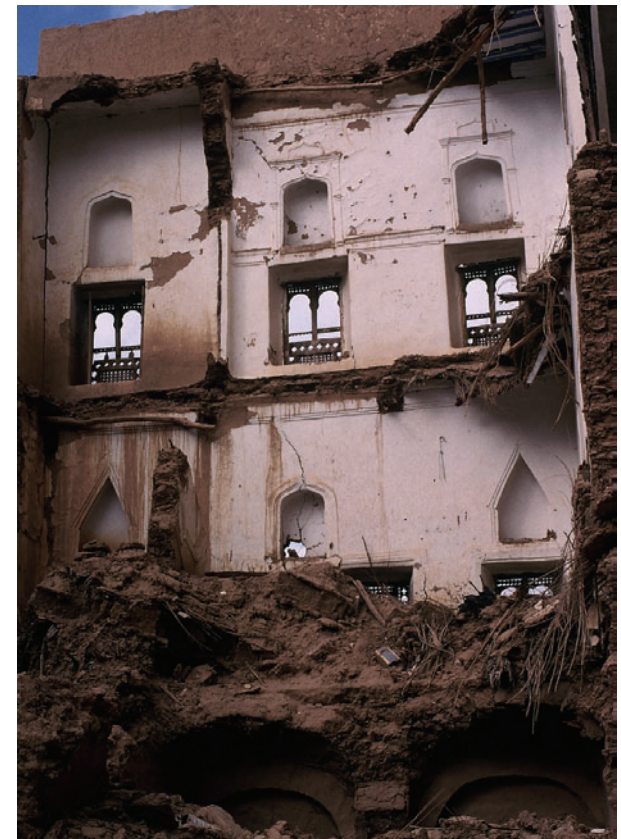
Abandoned historic building in Wadi Hadhramaut, in disrepair. Photo: © Pamela Jerome.

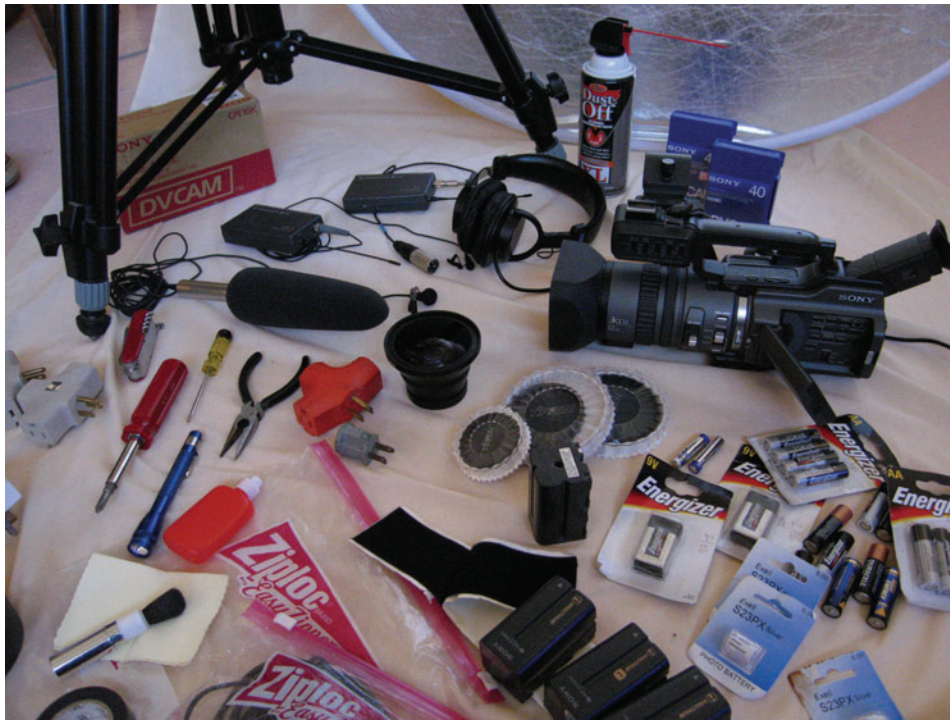
Field equipment used to make the documentary video, including a mini-digital video camera (DV cam pictured), tripod, extra rechargeable batteries, microphones, and various tools for work in the field. To protect the equipment from dust and sand, the camera and tapes were stored in resealable plastic bags. Photo: © Caterina Borelli.

Sound was extremely important, and three different types of microphones were used to cover all situations. Two wireless radio microphones including a lapel microphone were used for interviews. A Sennheiser shotgun microphone captured more precise areas of sound. Headphones were used to check the sound recording in the field. The recording medium was Sony high-grade mini-digital videotapes. These tapes and the camera were placed into resealable plastic bags to protect them from sand and dust. Each tape was carefully labeled and protected from erasure by using the switch on the videotape. At the end of each day of filming, a diary entry was made of where and when the video was captured. Canned air was used to clean the camera every night.

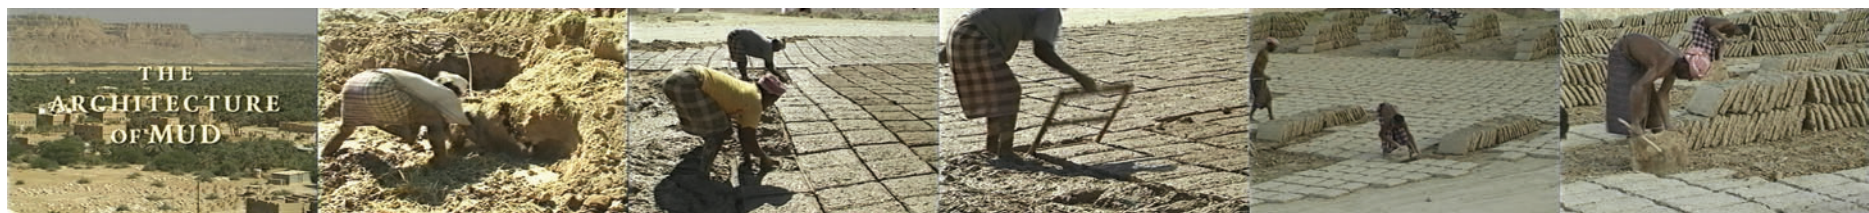
Series of stills from the documentary, showing workers in Seyoun creating mud bricks for new construction. Soil is gathered and mixed with straw and water. The mixture is spread out evenly in a mold, which is lifted immediately. The mud bricks are then left to dry in the sun for a week. Photos: © Caterina Borelli.

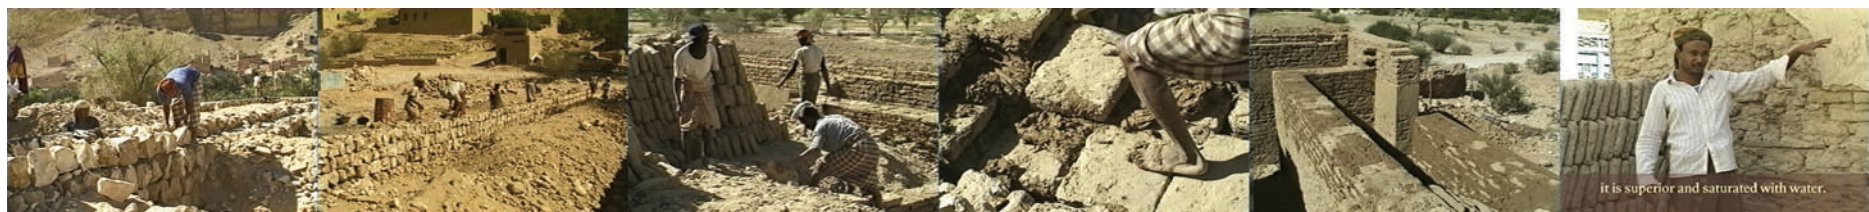
Series of stills from the documentary, showing workers erecting a new building. After the stone foundation is laid, the mud bricks are stacked to build a wall. Photos: © Caterina Borelli.

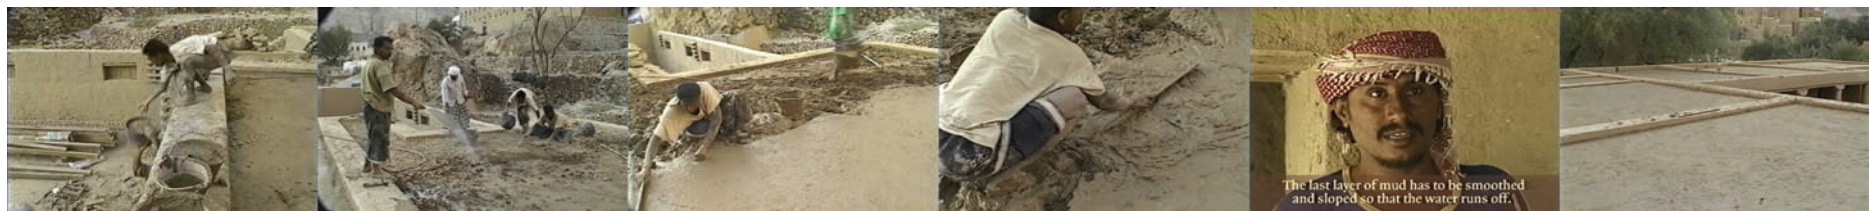
Series of stills from the documentary, showing the completion of a building. Workers are finishing off the new roof with mud. Photos: © Caterina Borelli.

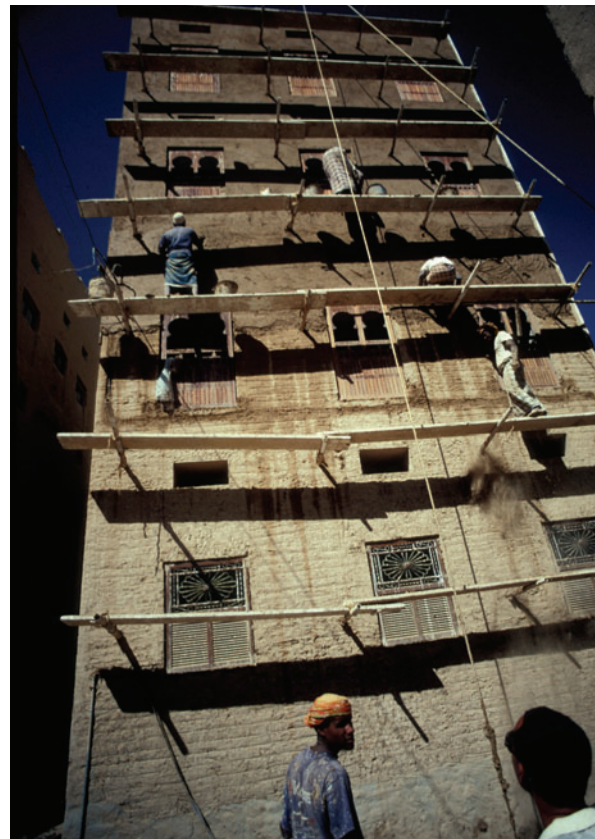
Ongoing maintenance efforts in Hadhramaut also involve plastering the exterior of buildings with mud to conserve the mud-brick construction. Photo: © Caterina Borelli.

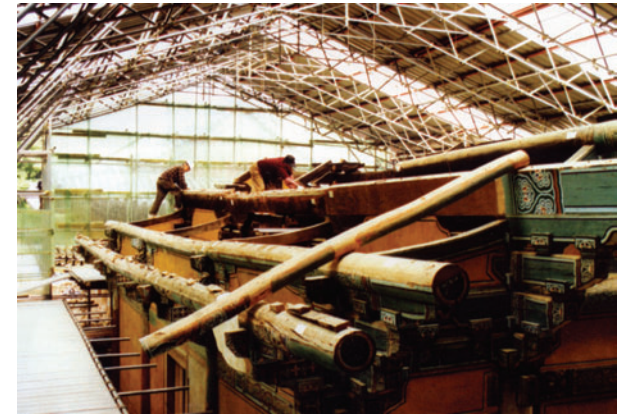
The Hall of Paradise, during restoration. Dismantlement of the temple allowed each building component to be documented individually. Photo: © Soon-Kwan Kim.

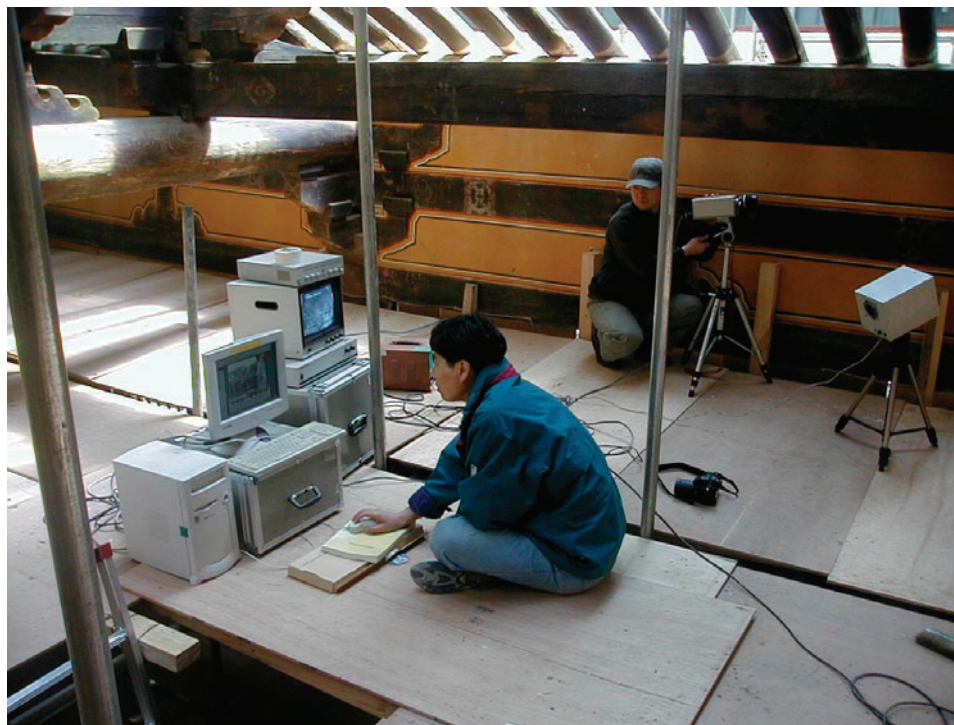
IRR acquisition of the images was conducted both on the individual components and in situ for the composite building. Photo: © Soon-Kwan Kim.

IRR instrumentation is affected by environmental conditions such as ambient temperature and humidity and is very sensitive to light and motion. Therefore, members of the study team carefully controlled their surroundings by positioning the instrument on a flat, stable work surface and maintaining uniform lighting. They also bracketed exposures, taking multiple images of the same subject using slightly different settings. This

Over the course of five days, more than six hundred IRR and conventional images were captured and processed. Processing consisted of quality control with the Zeiss KS 300 Image Analyzer program and editing for contrast and brightness using Adobe Photoshop. Photoshop was also used to assemble multiple images of large objects, as the IRR instrument used for this survey had a low-resolution (4800 dpi) detector, which limited the size of each image.

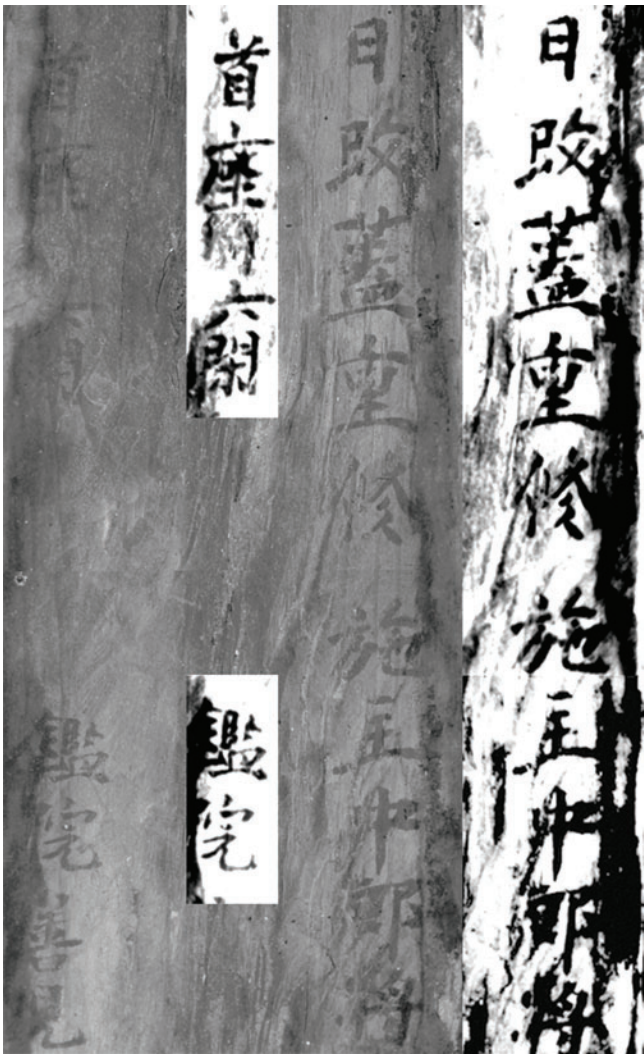
二十三年	in the 23rd year of the emperor
Yu-khan	六閑		始蓋重修	repairs were made to the roof
Construction manager	監製		齋主	paid for by donations of
Seong-yun	善見		中浪	General Yi-chim

IRR was used to reevaluate visible-light photography of the top purlin in the Hall of Paradise. During restoration work in 1972, surveyors studying the Chinese characters by eye had misinterpreted the writing, resulting in inaccuracies in the archival record. Through the use of IRR in the 2002 survey, a character misidentified as “owner” was corrected to mean “caution.” Photo: © Soon-Kwan Kim.

The application of IRR at Bongjeongsa was successful in uncovering many important clues regarding the history of these buildings. Except for a few entirely missing or heavily soiled characters, most of the writings on the wooden members were successfully interpreted. Chronology of the numerous restorations, significant structural changes, original positions of the wooden members, and names of those involved in the ancient restorations were identified and documented. Archival records were corrected based on this study, making it possible to piece together entire periods in the history of the buildings. This information supported the 2002 reconstruction by assisting team members in dating and identifying important pieces that should receive special attention. Pieces that could be reused were also identified and carefully “reinserted” during reconstruction. Pieces that had deteriorated were conserved and eventually may be placed on display.
